**Thompson Falls Hydroelectric Project  
FERC Project No. 1869**

**NorthWestern Energy  
Initial Study Report  
Operations Study**

April 2022

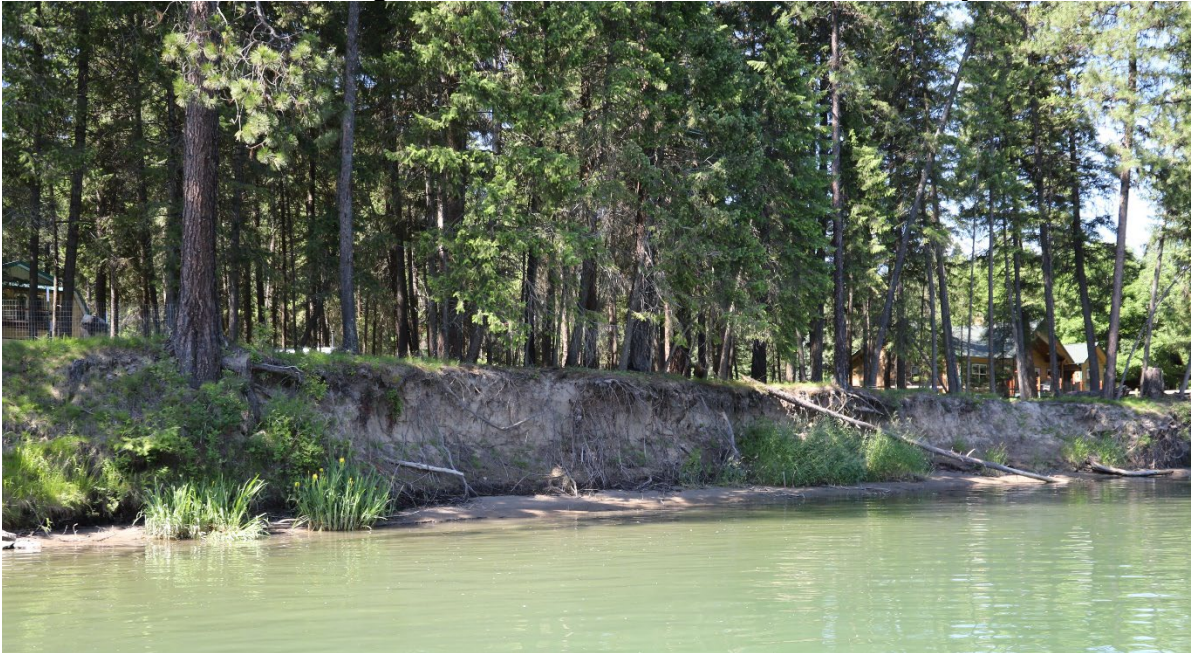
**Photo 3-6. Photos of Eroding Bank Before Shoreline Stabilization Pilot Project**

The pilot project consisted of using 20 conifer trees from on-site to create a stable toe of woody debris, sloping back the bank from near vertical to a 2:1 to 3:1 slope, and planting 230 native species shrubs and 1,400 willow and dogwood cuttings.

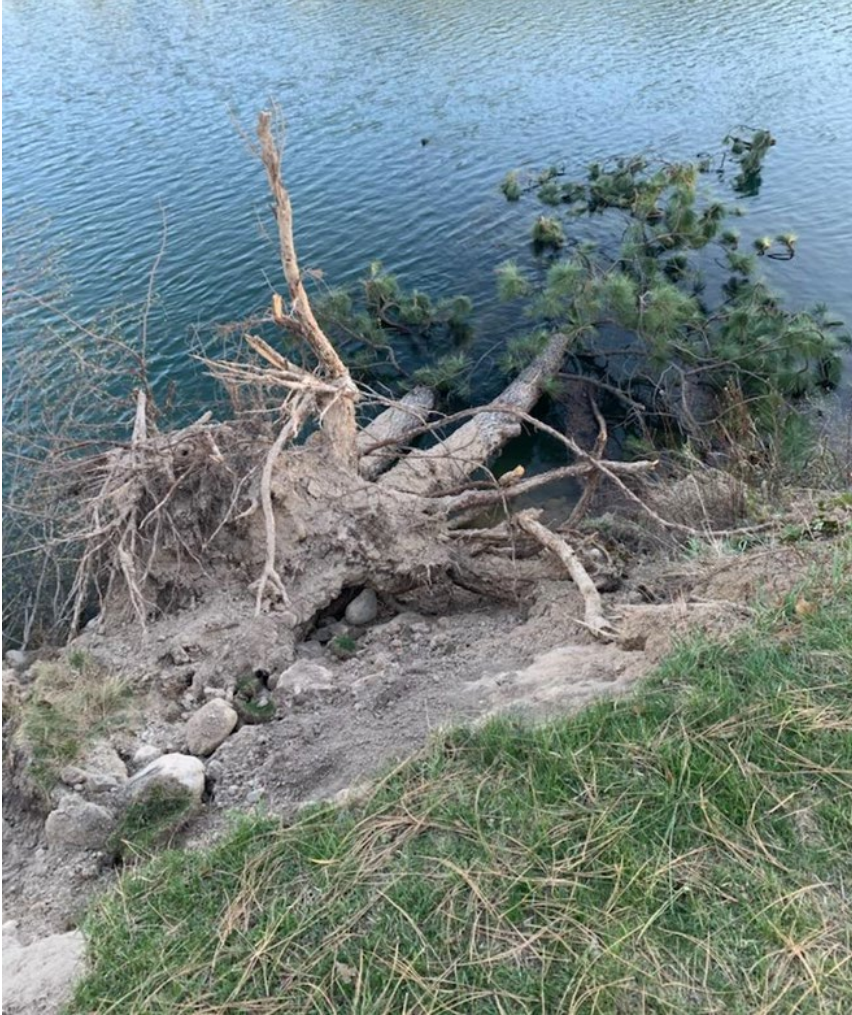
**Photo 3-11. Tree Uprooted by Windstorm and Resulting Damage to the Bank**

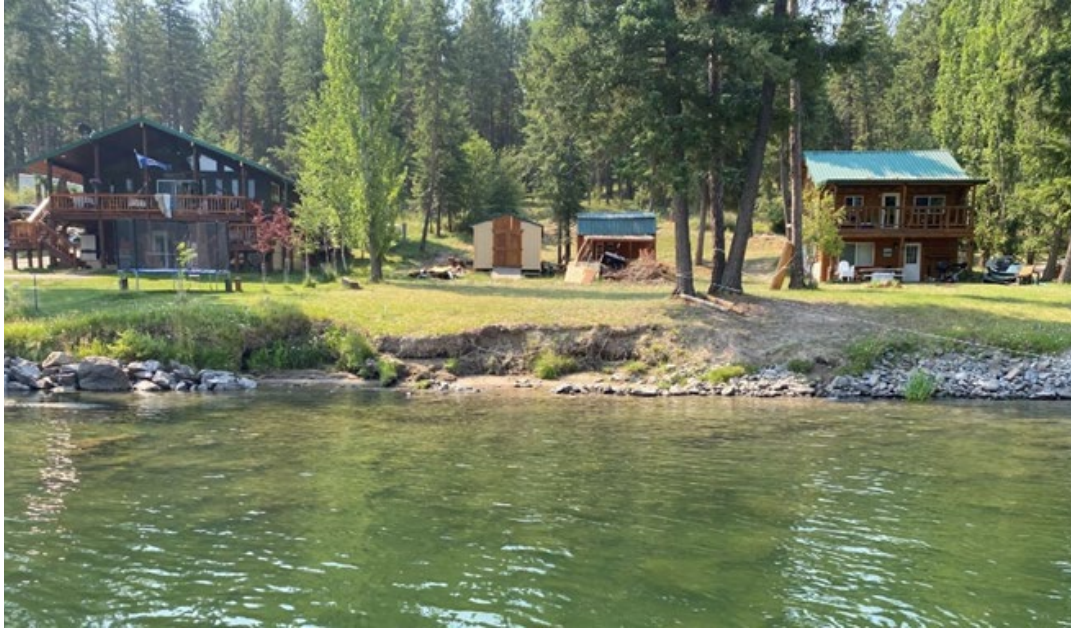
A 15-foot-long and 4-foot-high section of shoreline near the last few developed properties on the south shore, just upstream of the mouth of Cherry Creek, was observed to have slumped off into the reservoir (**Photo 3-12**). Based on conversations with neighboring landowners, the erosion had been occurring for a while (not just since spring 2021) and the cause of the bank slumping is attributed to the rock rip-rap just upstream (on the left side of the photo) which may have created a nick point.

**Photo 3-12. Slumped Shoreline – Nick Point Created by the Upstream Rock Rip-rap (left side of photo)**

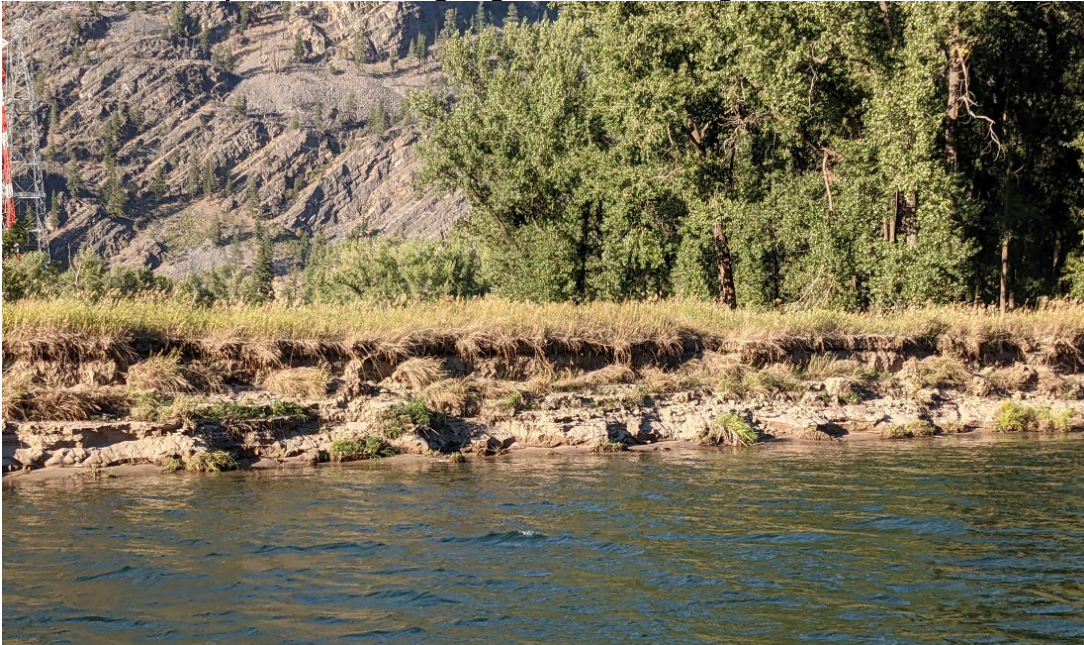
On August 31, 2021, observations were made of shoreline stability from the Thompson River to the upstream end of the Project boundary. This area is more riverine than the area downstream of the Thompson River, and the observations are consistent with riverine conditions. Erosion, deposition, and August water levels well below the high-water mark were all observed. The area around the islands in particular demonstrated active bank sloughing and undercutting (**Photo 3-13**) from spring runoff and perhaps even from lower water flows. Where the shoreline is composed of finely grained material (sands/silts/clay), vertical banks up to 6 feet tall were common, with bank sloughing also common. This shoreline condition existed on both the island shorelines and the mainland shoreline, but more prevalent on the island shorelines since some of the mainland shoreline in this area is bedrock or large rock. The water is shallower in this area, and it is located further away from the City of Thompson Falls and public boat launches, so this area likely gets much less boat traffic than other portions of the reservoir. Erosion in this area is most likely due to ice scour and water current since it is more riverine in nature. Erosion is not the only process that is occurring, however, as areas of deposition were also noted in the islands area (**Photo 3-14**). In essence, the shapes, sizes and locations of the islands are always shifting which would be expected in a normally functioning riverine system.

**Photo 3-13. Example of Bank Sloughing and Undercutting in Island Area**

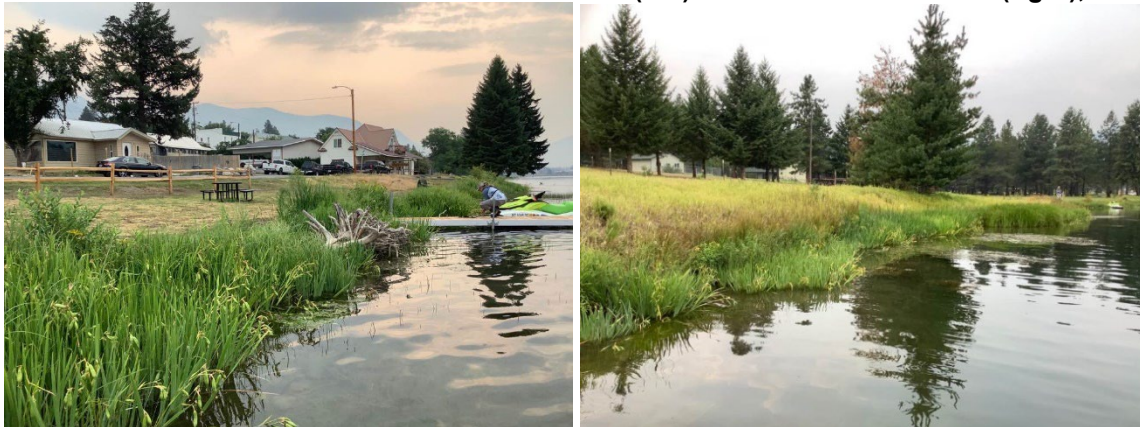
AIS were observed at six of the nine reference points with flowering rush and yellow flag iris being the species observed. Curlyleaf pondweed was not observed at any of the nine reference points. The presence of yellow flag iris and flowering rush varied greatly from being a few isolated plants to close to 100 percent of the 300-foot-long reach. The prevalence of these species also varied depending on time of year. **Photo 3-18** contains two photos from the August 6 monitoring event, one of Reference Point #1 which shows a high prevalence of yellow flag iris and flowering rush, and one of Reference Point #2 which shows a high prevalence of yellow flag iris (other species in photo mostly native species).

**Photo 3-18. AIS Prevalence at Reference Point #1 (left) and Reference Point #2 (right), 8/6/21**

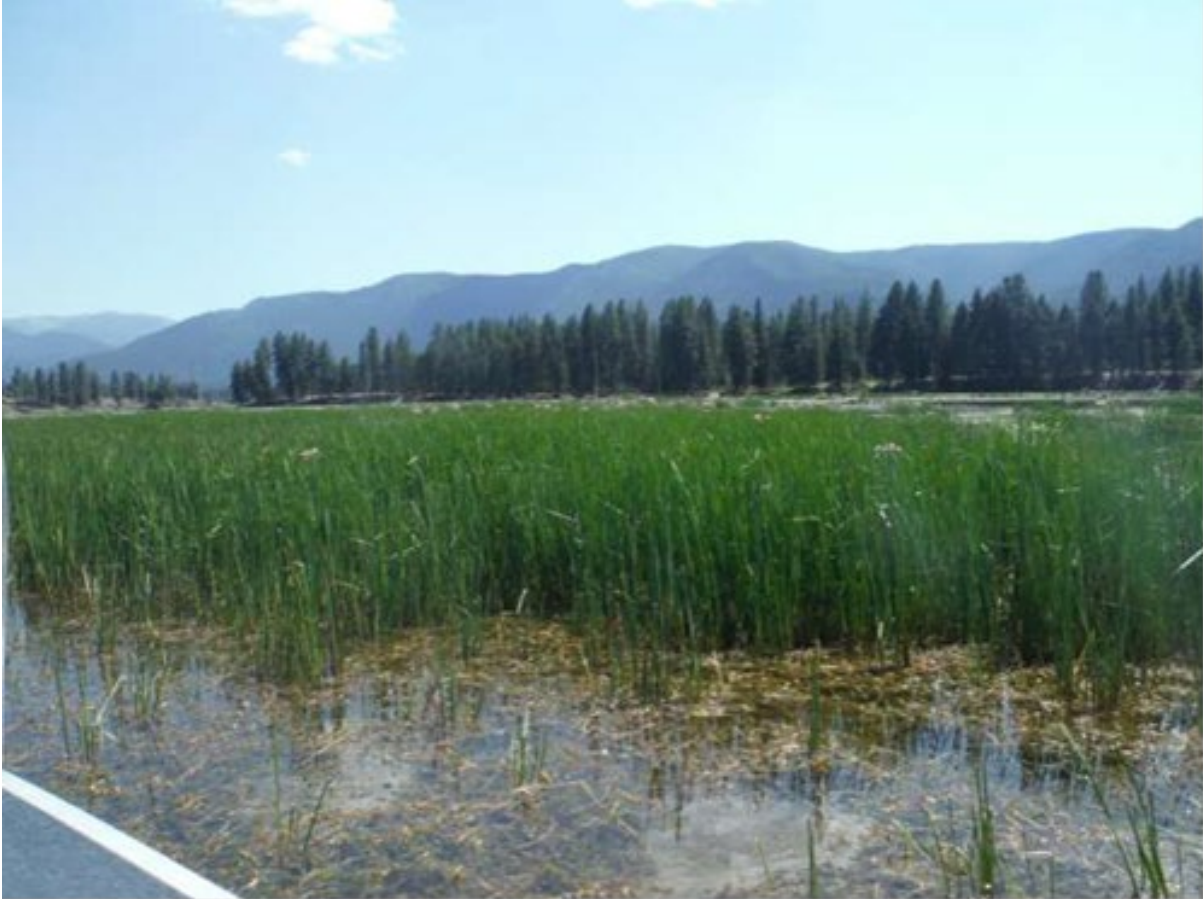
**Photo 3-19. Lower Reservoir Area with a High Prevalence of Flowering Rush**

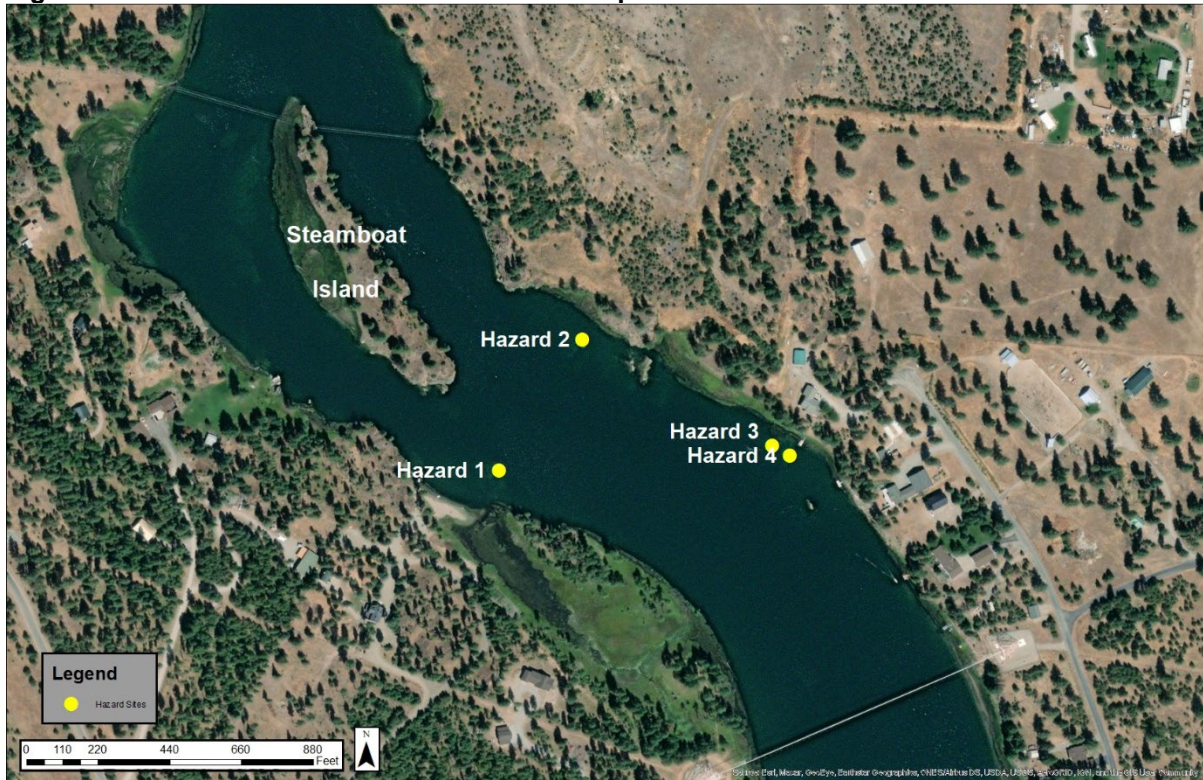
**Figure 3-24. Location of Hazardous Rock Outcrops**

The depths of these hazards were monitored during each half-foot static hold to determine how risk to public safety changes with water elevations in these four locations. Hazards 1 and 2 were submerged at full pool to depths of 4 and 2.5 feet respectively (**Figure 3-25**). As the reservoir elevation was lowered in response to increased generation, these hazards approached the surface. Hazard 1 remained submerged but high enough in the water column to pose a risk to watercraft at only 1.5 feet deep after the reservoir reached an elevation of 2.5 feet below full pool. Hazard 2 became visible when the reservoir elevation was down 2.5 feet and was within about 1 foot of the surface when the reservoir was down 1.5 feet. Since these hazards moved higher into the water column the risk of contact with these hazards increased as the reservoir elevation was lowered.
