**Thompson Falls Hydroelectric Project
FERC Project No. 1869
Final Study Report – Operations Study**

May 2023

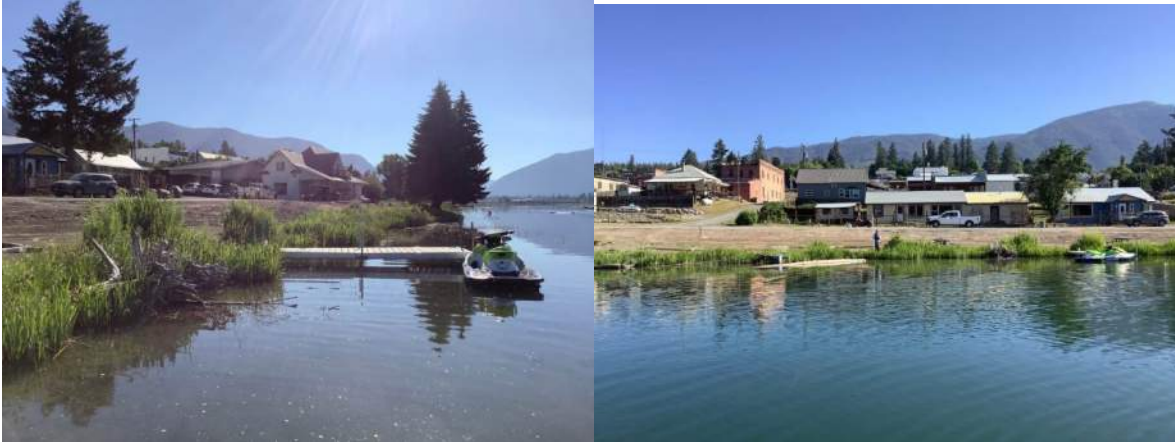
Photo 3-1. Representative Photos of Shoreline Stability Reference Point #1.

Both monitoring events indicated 0 to 10 percent erosion, with minimal erosion observed (closer to 0% than 10%). This is no change from the six monitoring events completed in the first study season (NorthWestern 2022). The only type of erosion noted was rill or gully erosion and the only cause noted was human-created footpaths to the reservoir's edge. Once created, the footpaths in turn collected and funneled water from rainfall or snowmelt resulting in the rills or gullies.

Bank profile looking upstream from mid-point, and middle 100 feet of the 300-foot reach.

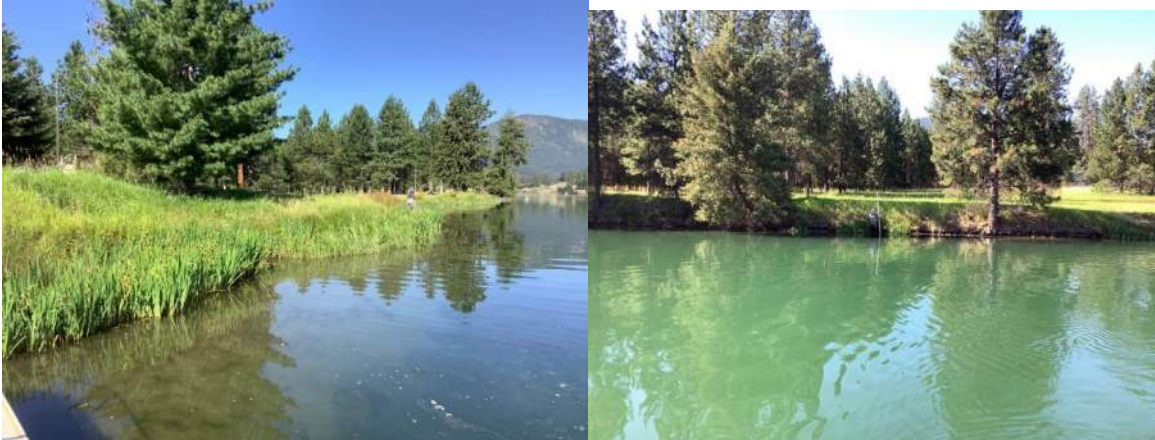
Photo 3-2. Representative Photos of Shoreline Stability Reference Point #2.

Bank profile looking downstream from mid-point, and upper 100 feet of the 300-foot reach.

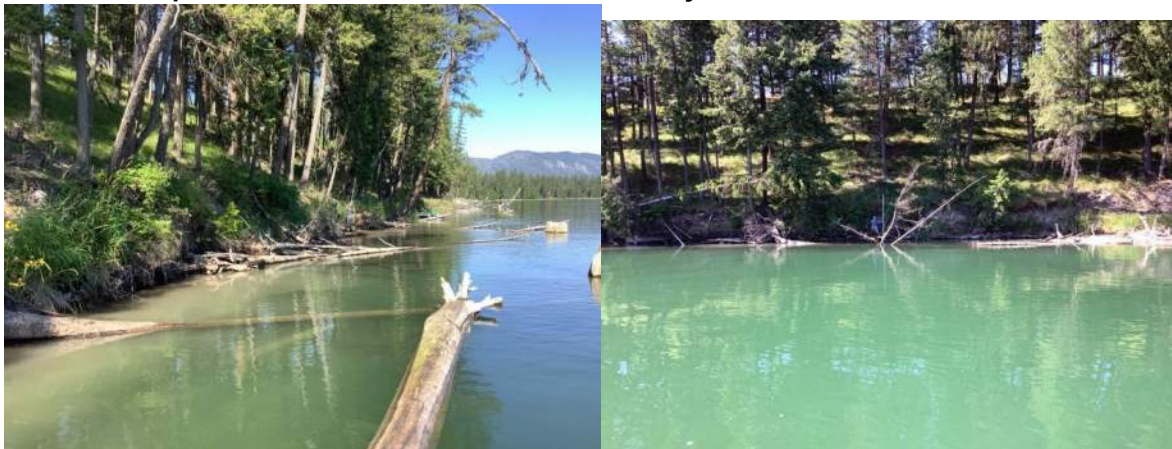
Photo 3-4. Representative Photos of Shoreline Stability Reference Point #4.

Reference Point #4 is in Land Facet 9(1) which is not one identified as a facet that is prone to shoreline instability, but it nonetheless had a significant amount of shoreline instability caused by high spring flows.

Bank profile looking downstream from mid-point, and upper 100 feet of the 300-foot reach.

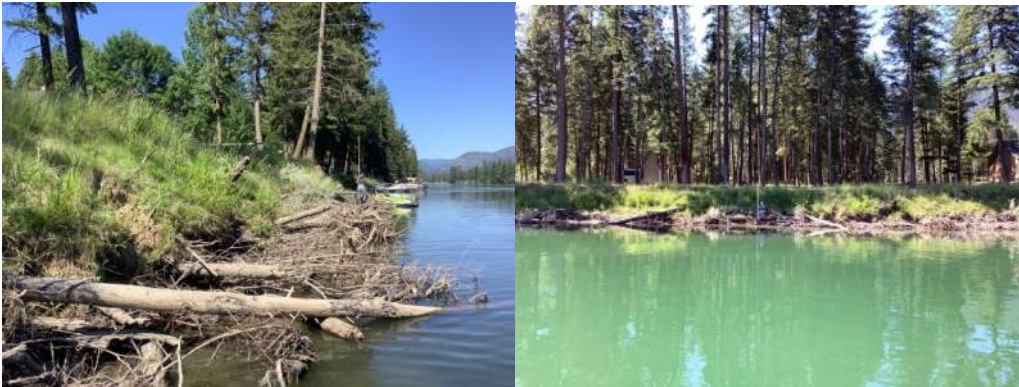
Photo 3-5. Representative Photos of Shoreline Stability Reference Point #5

Reference Point #5 had a significant amount of erosion in the past, but a shoreline stabilization project completed in 2020 has successfully resulted in a stable shoreline and only minor new erosion was noted.

Bank profile looking downstream from mid-point, and lower 100 feet of the 300-foot reach.

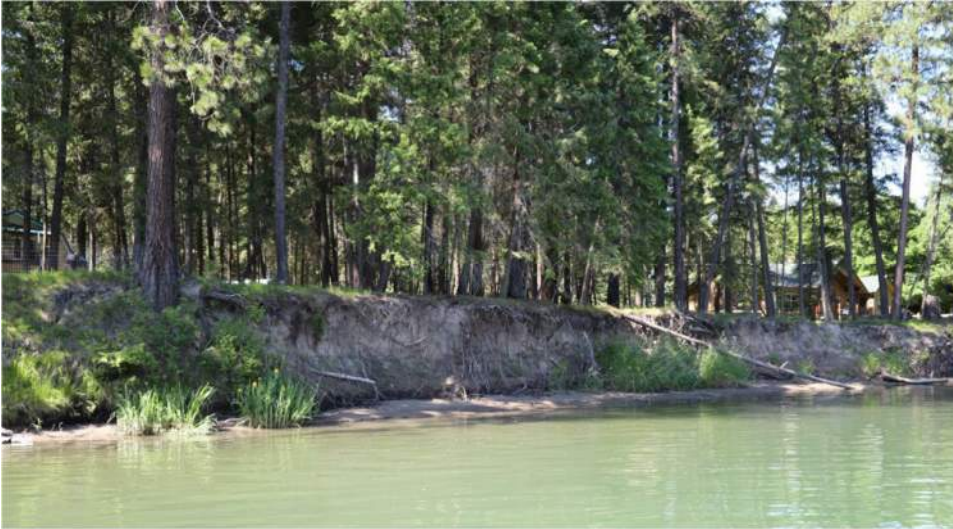
Photo 3-6. Photos of Eroding Bank Before Shoreline Stabilization Pilot Project.

Bank profile looking at a slight downstream angle from the upstream end of the segment.

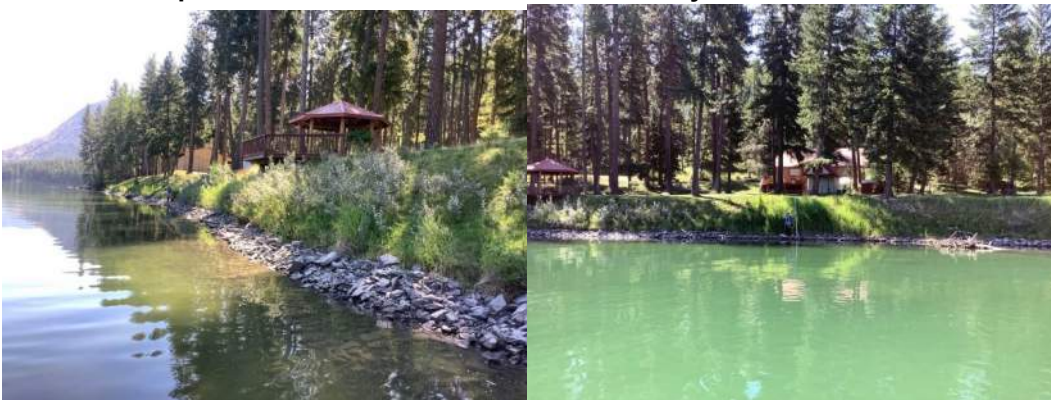
Photo 3-8. Representative Photos of Shoreline Stability Reference Point #7

Reference Point #7 a shoreline stabilization project completed sometime in the last 10 to 20 years has successfully resulted in a stable shoreline and no new erosion was noted.

Bank profile looking upstream from mid-point, and middle 100 feet of the 300-foot reach.

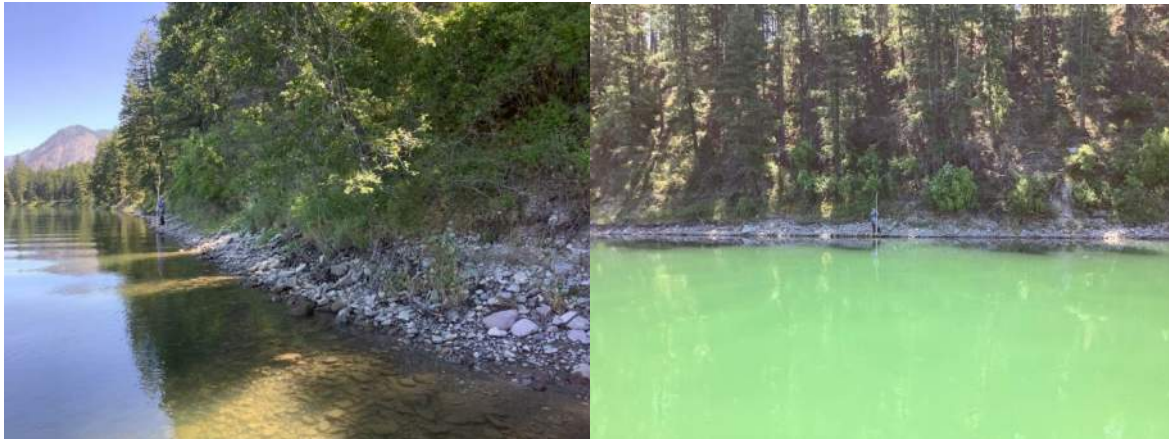
Photo 3-9. Representative Photos of Shoreline Stability Reference Point #8.

Reference Point #8 is in Land Facet 8(2) which is a bouldery variant, and as noted in NorthWestern (2020), the shoreline erosion in this Land Facet is anomalous because bouldery substrates tend to be more stable. Increased fetch distances may be creating more wave erosion in this Land Facet (NorthWestern 2020).

Bank profile looking upstream from mid-point, and upper 100 feet of the 300-foot reach.

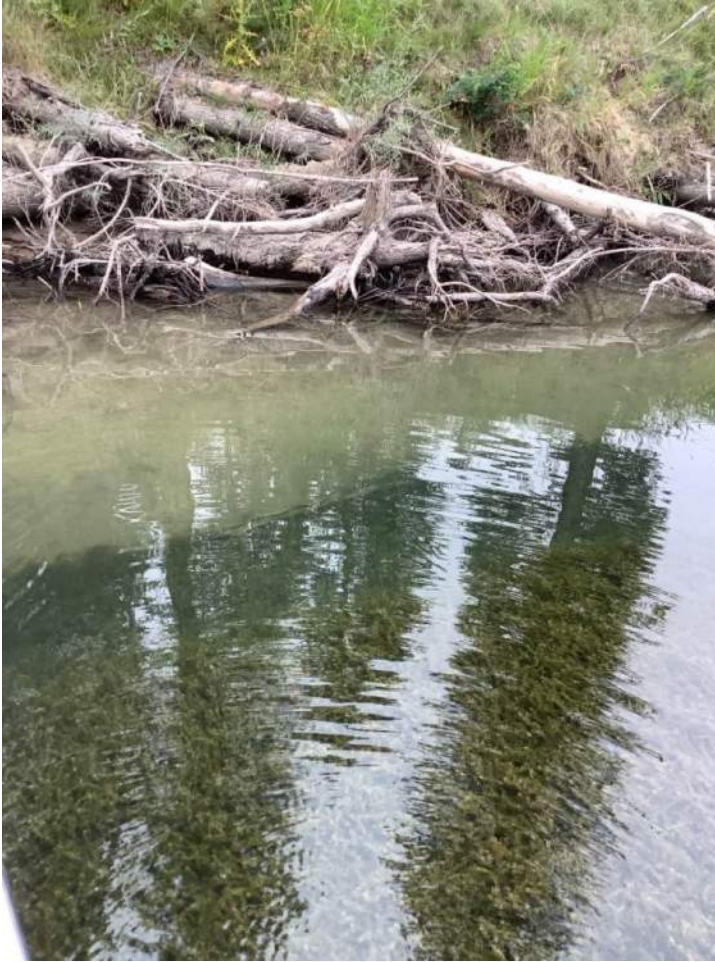
Photo 3-15. Reference Point #5 September 13, 2022.

Note lower density of submergent aquatic vegetation in the 0- to 18-inch-depth range, and dense submergent aquatic vegetation at depths greater than 18 inches.

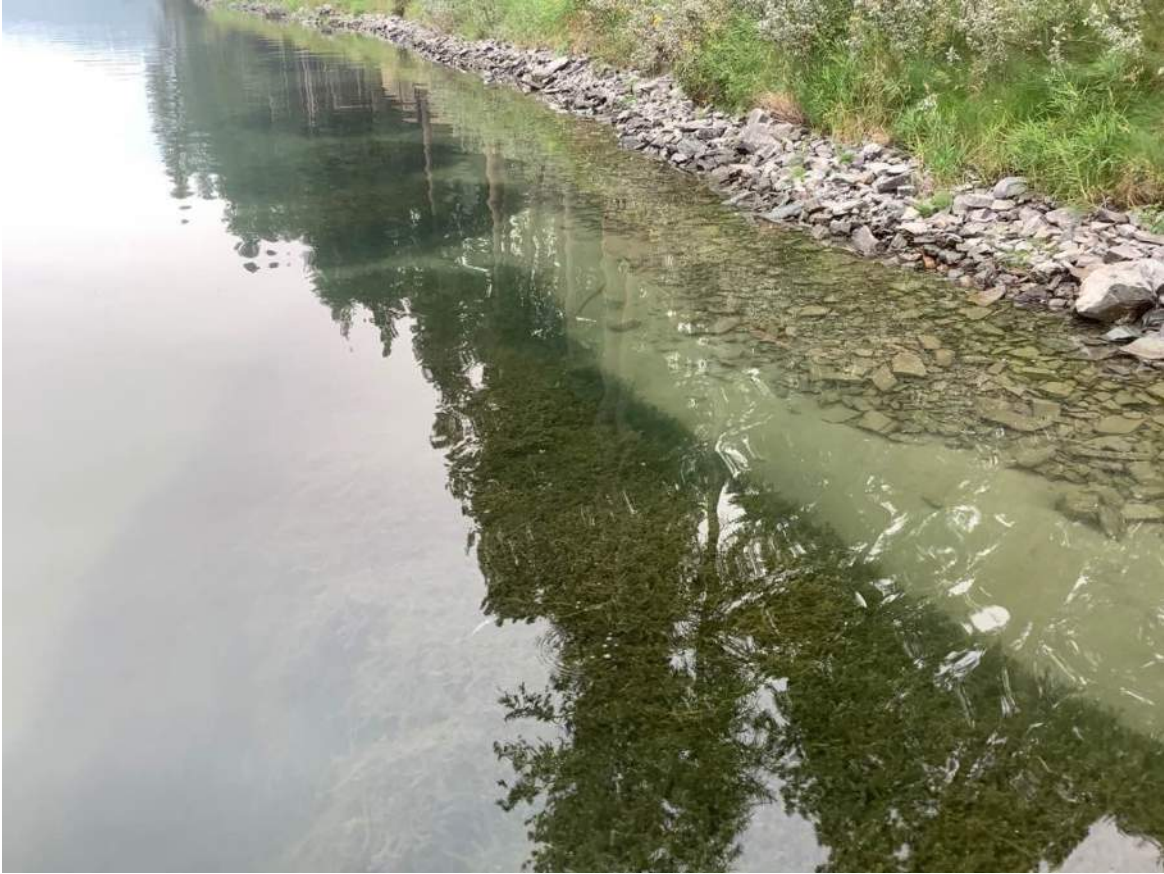
Photo 3-16. Reference Point #8, September 13, 2022

Note lower density of submergent aquatic vegetation in the 0- to 18-inch-depth range, and dense submergent aquatic vegetation at depths greater than 18 inches.

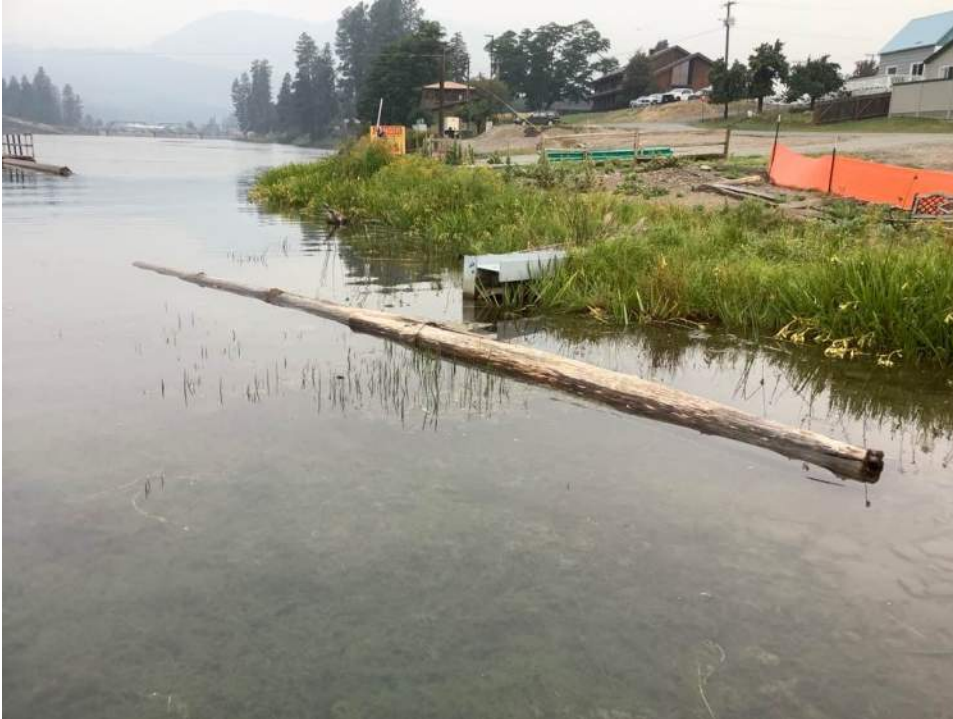
Photo 3-17. Reference Point #1, September 13, 2022.

Note high density of emergent aquatic vegetation along the shoreline.

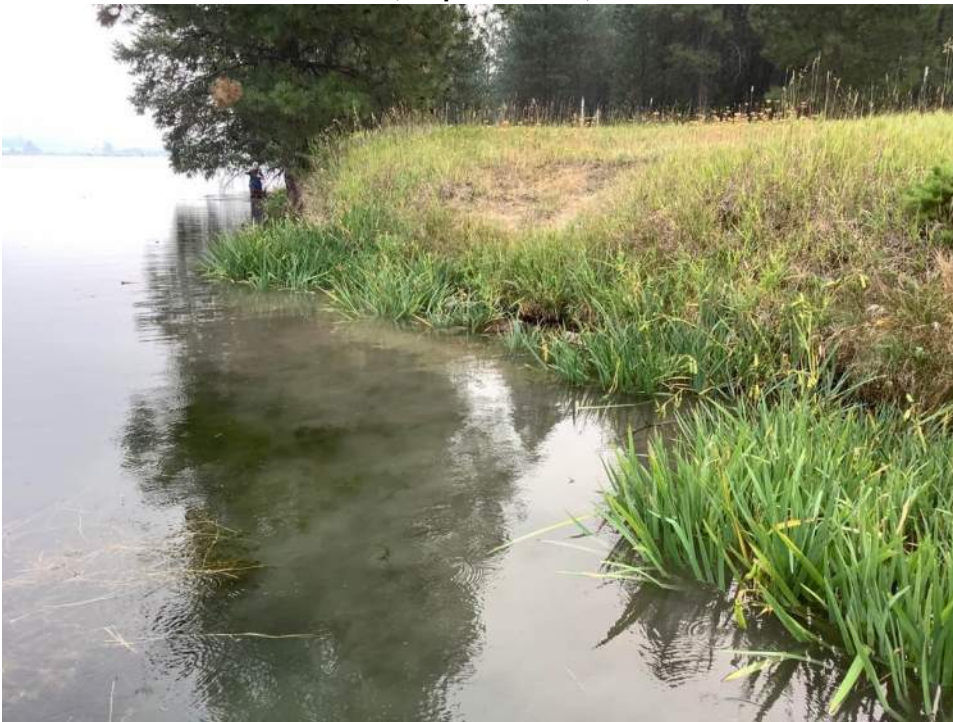
Photo 3-18. Reference Point #2, September 13, 2022.

Note high density of emergent aquatic vegetation along the shoreline.

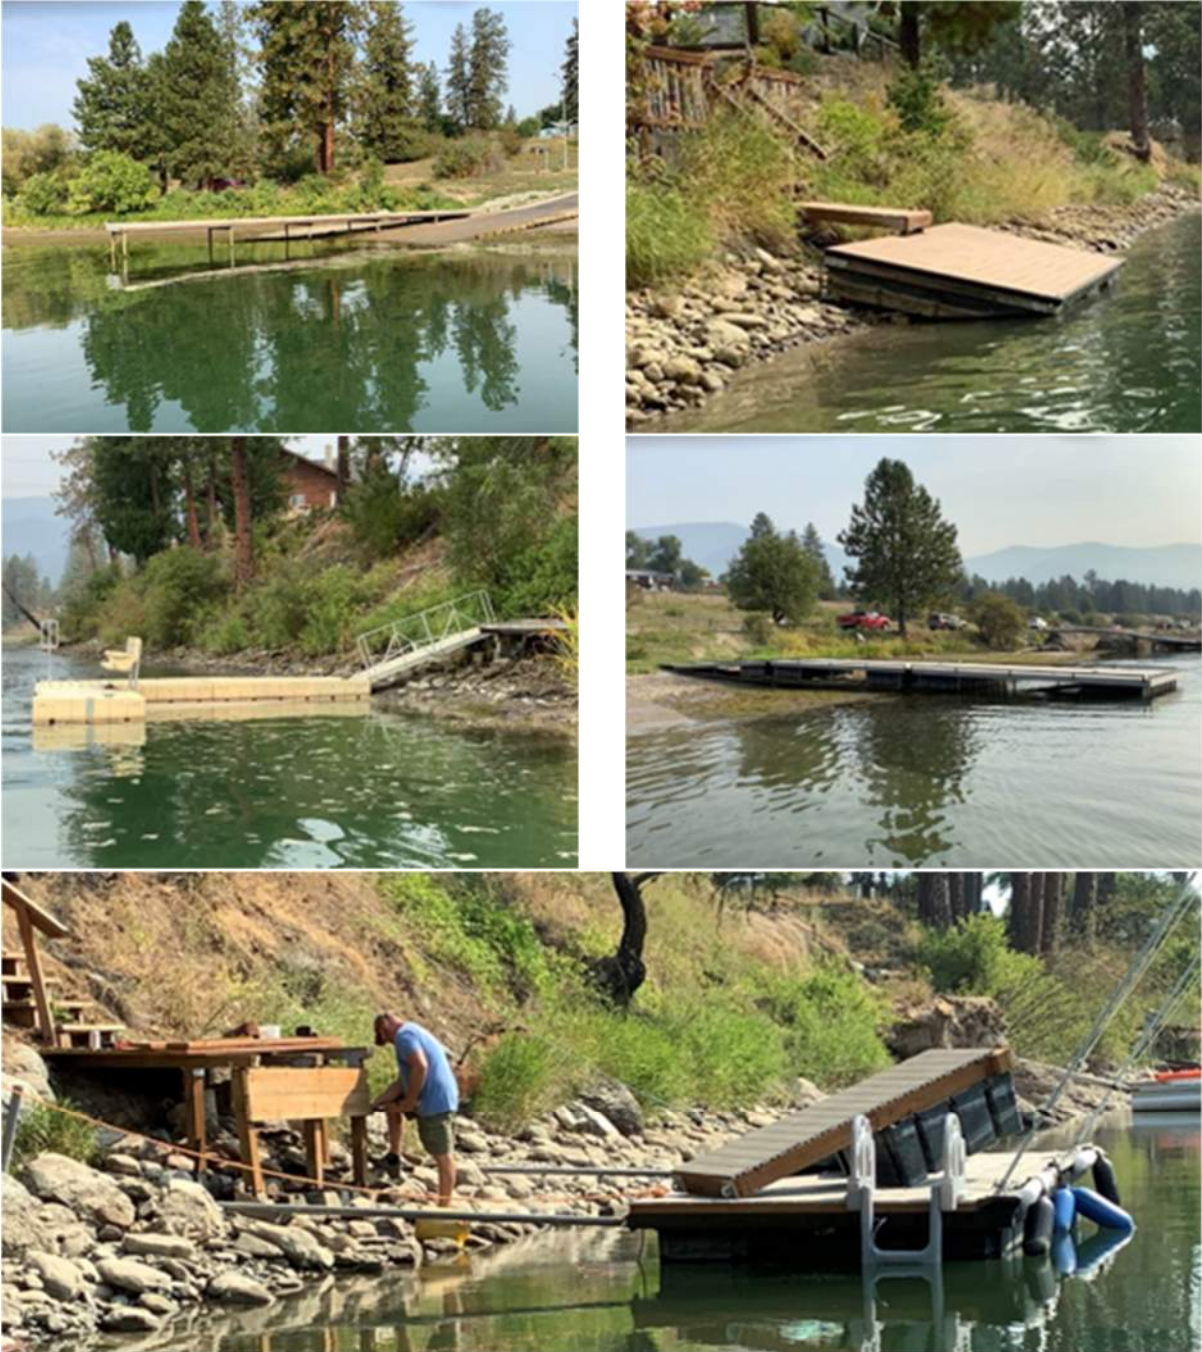
Photos 3-19. Impacts to Docks at Varying Water Elevations.

Notes: Stationary dock, Wild Goose Landing (public dock), no structural impact to the dock at -2.5 feet reservoir elevation (top left). A floating dock with near-shore grounding at -2.5 feet reservoir elevation (top right). Floating docks with no structural impacts at -2.5 feet reservoir elevation (middle). Floating dock gangway damaged at -2.0 feet reservoir elevation (bottom). These photos are from the 2021 Study Season.

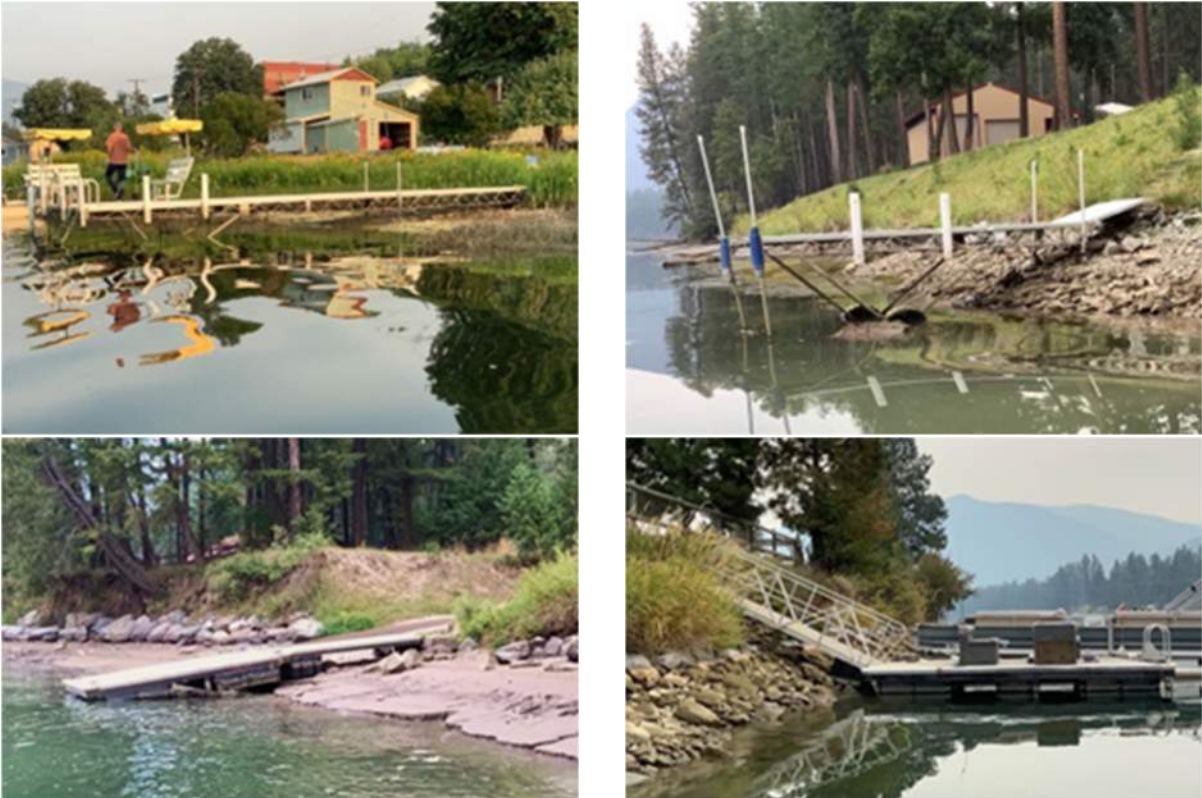
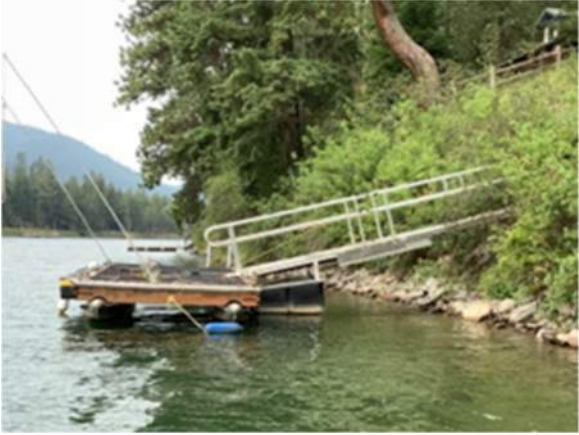
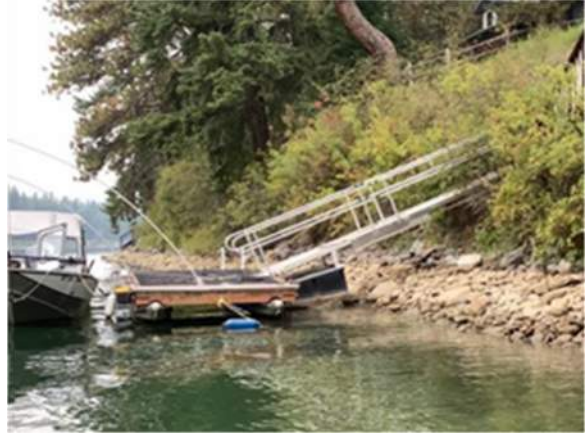
Photos 3-20: Impacts to Dock Access at Varying Water Elevations.

Notes: Access to stationary docks remains unchanged at low water elevations (top). The outer edge of the floating dock at Cherry Creek Boat Launch (public dock) remains floating at -2.5 feet reservoir elevation but the dock becomes pitched (middle left). A private dock on the south shoreline with a steep gangway and entirely floating dock that minimally impacts access at -2.5 feet reservoir elevation (middle right). A floating dock and gangway ramp at full pool (bottom left) and at -2.5 feet below full pool, with minimally impacted access (bottom right). These photos are from the 2021 Study Season.

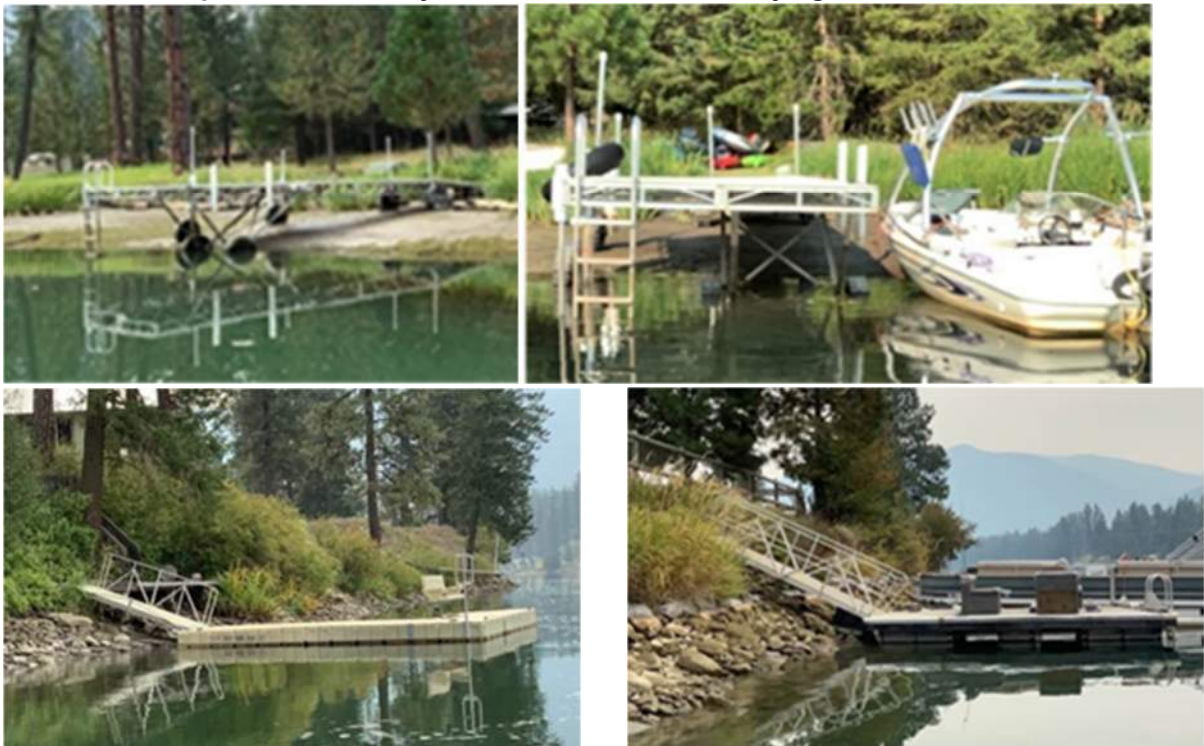
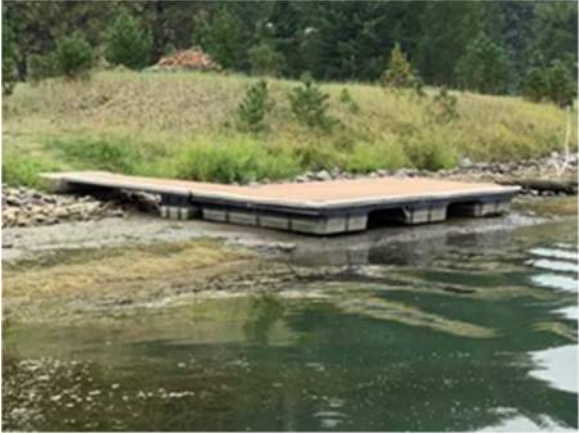
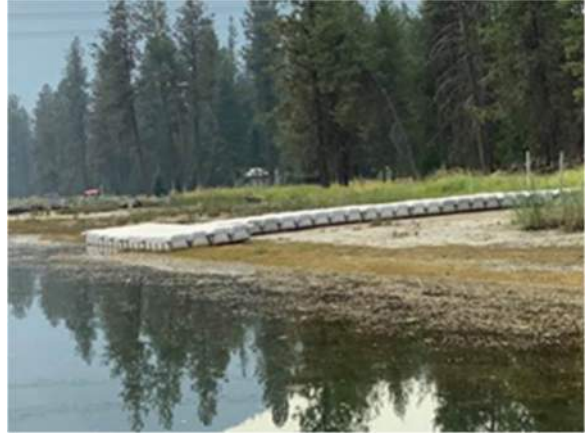
Photos 3-21. Impacts to Waterway Access from Docks at Varying Water Elevations.

Notes: Stationary docks that remain watered (though shallow) with swim ladders that reach the water surface at -2.5 feet reservoir elevation (top). Floating docks that are appropriate for waterway access at -2.5 feet reservoir elevation (middle). Dewatered floating docks at -2.5 feet reservoir elevation (bottom). These photos are from the 2021 Study Season.

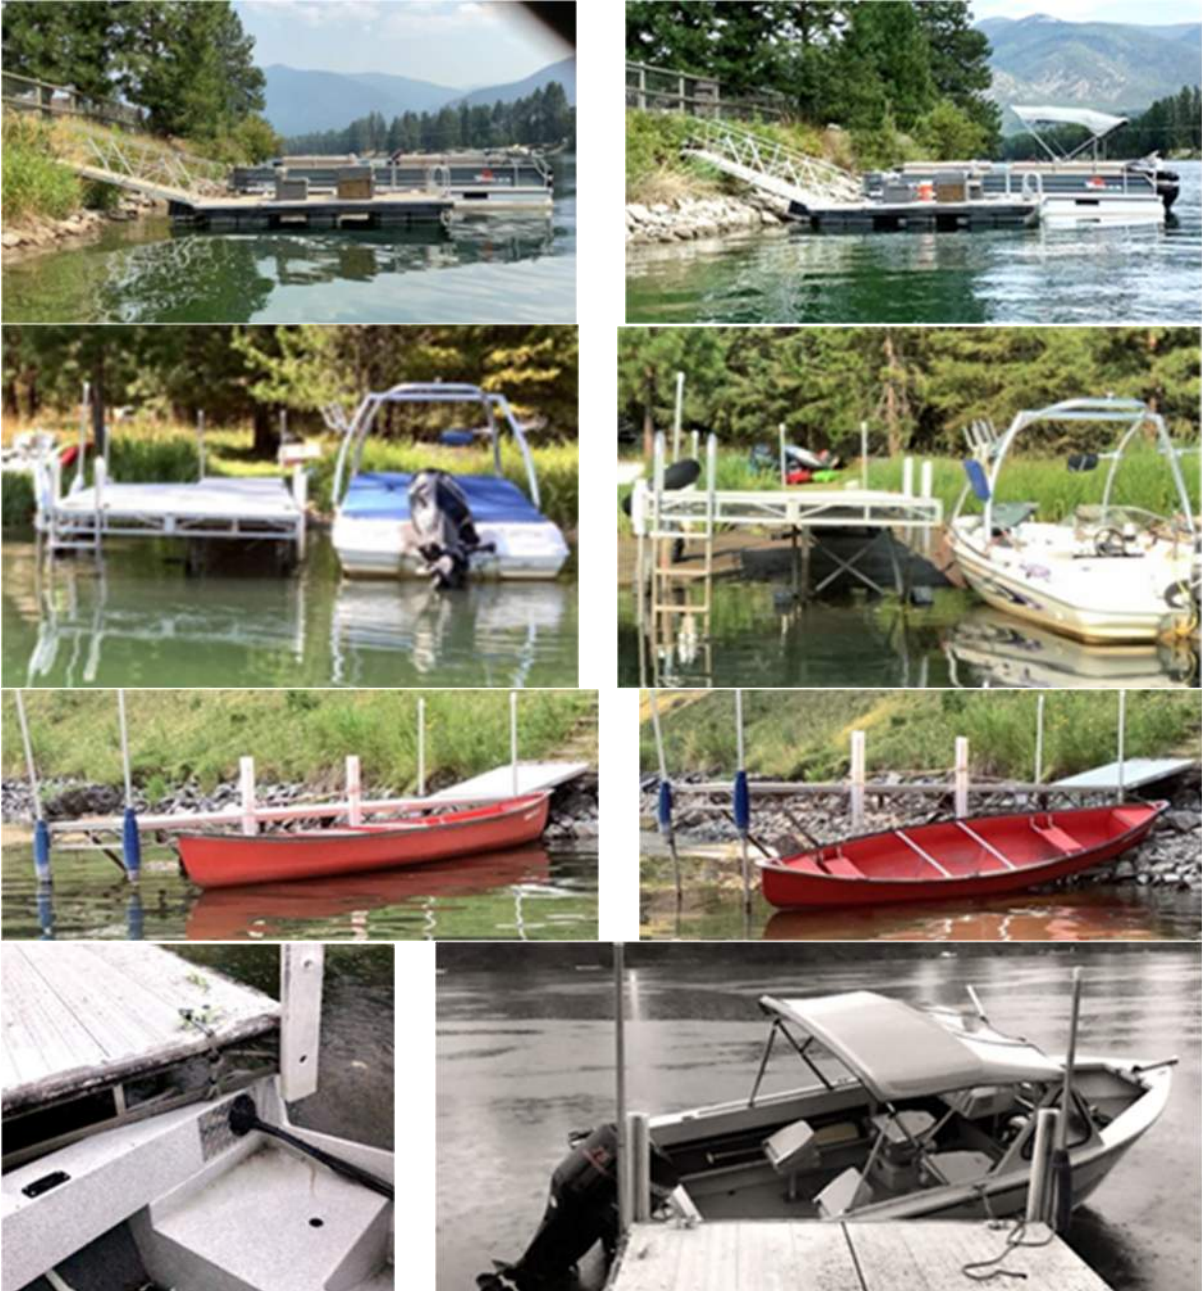
Photos 3-22: Impacts to Boats Moored at Docks at Varying Reservoir Elevations.

Notes: Floating docks allow access to boats at all elevations (top). Increase in vertical distance to boat from stationary dock at -2.0 feet reservoir elevation (second row). Boats tightly tied to stationary docks may not remain floating when water levels recede (third row). Boat pinned under stationary dock when reservoir elevation returned to full pool from reduced elevations (bottom). These photos are from the 2021 Study Season.
