**Thompson Falls Hydroelectric Project  
FERC Project No. 1869  
Final License Application  
Volume II of IV (Public)  
Exhibit E: Environmental Report**

Prepared by:  
**NorthWestern Energy**  
Butte, MT 59701

December 2023

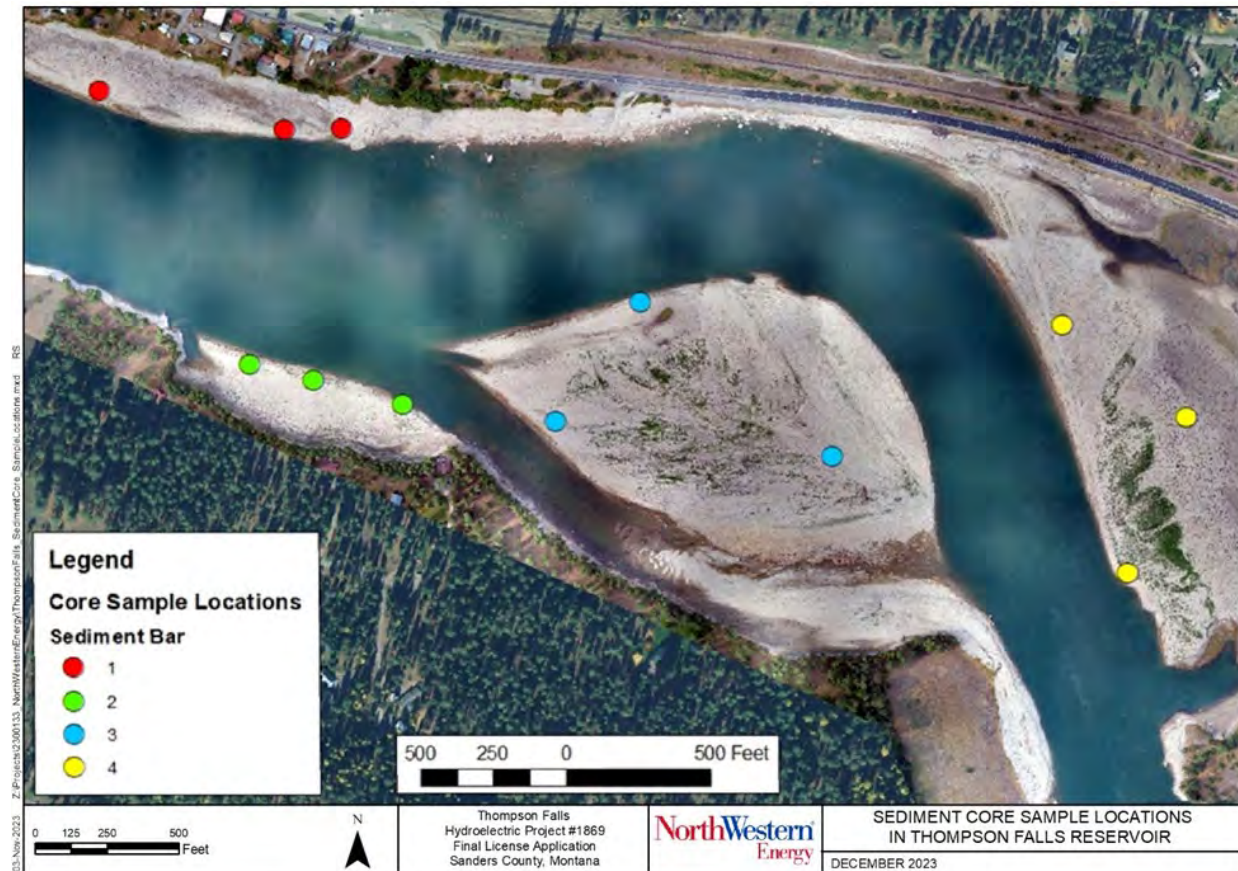
**Figure 6-10: Sediment core sample locations in Thompson Falls Reservoir on 7/13/20.**

Analytical results from the sediment core samples are shown in **Table 6-3** through **Table 6-5**, below. Table 6-3 shows the results of the Toxicity Characteristic Leaching Procedure (TCLP) metals analysis for each composite sample. TCLP is an analysis used to determine the potential

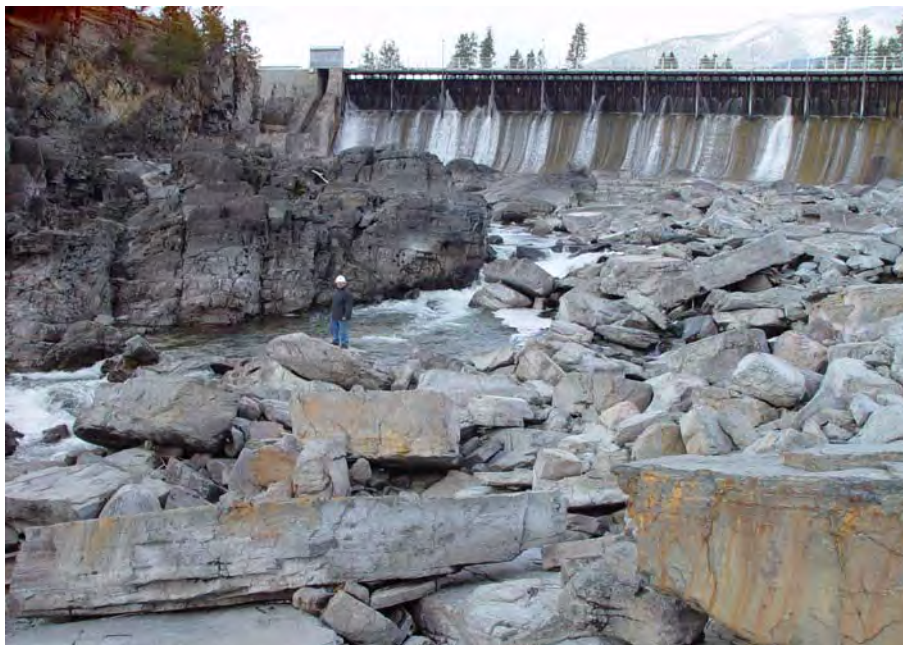
Figure 4 – Steep center thalweg and “falls” roughness.
