**Thompson Falls Hydroelectric Project  
FERC Project No. 1869**

**NorthWestern Energy  
Initial Study Report  
Operations Study**

April 2022

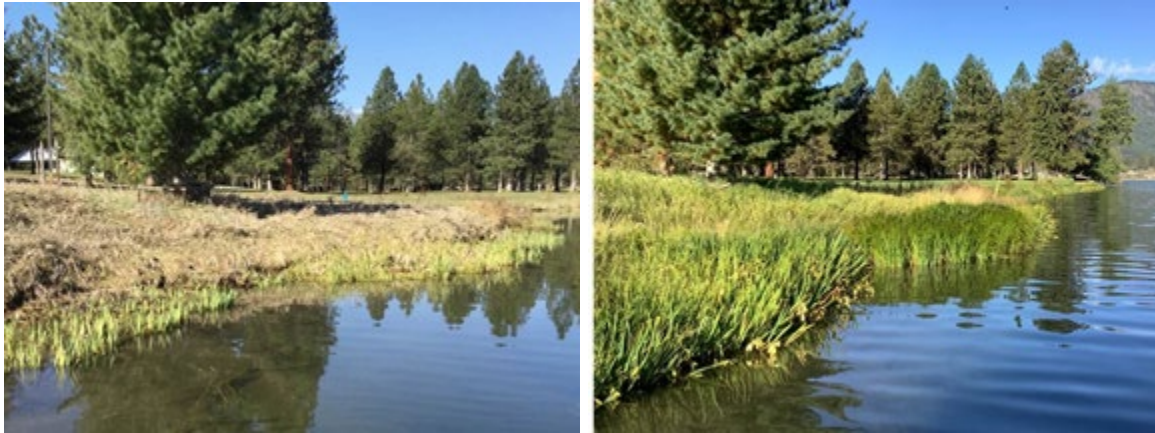
**Photo 2-1. Vegetative Growth During 4/19/21 (left) and 9/16/21 (right) Monitoring Events.**

Shoreline vegetative conditions were dramatically different between both October 8, 2020 and April 19, 2021 when vegetation was dormant, as compared with the growing season monitoring events in the summer and early fall in 2021 when vegetation was present and much denser. This challenge arose at Reference Points #1, #2, and #3. This limited the ability to observe bank erosion at these three reference points which were heavily vegetated as can be seen in **Photo 2-1**.

NorthWestern compared photos and data from all six monitoring events at these three reference points, to determine if an adjustment was needed to account for the dense vegetation. Fortunately, erosion at all three reference points was low for all monitoring events, likely because the increased density of shoreline vegetation throughout the growing seasons helps to reduce the susceptibility to erosion. Therefore, no significant adjustments were needed.

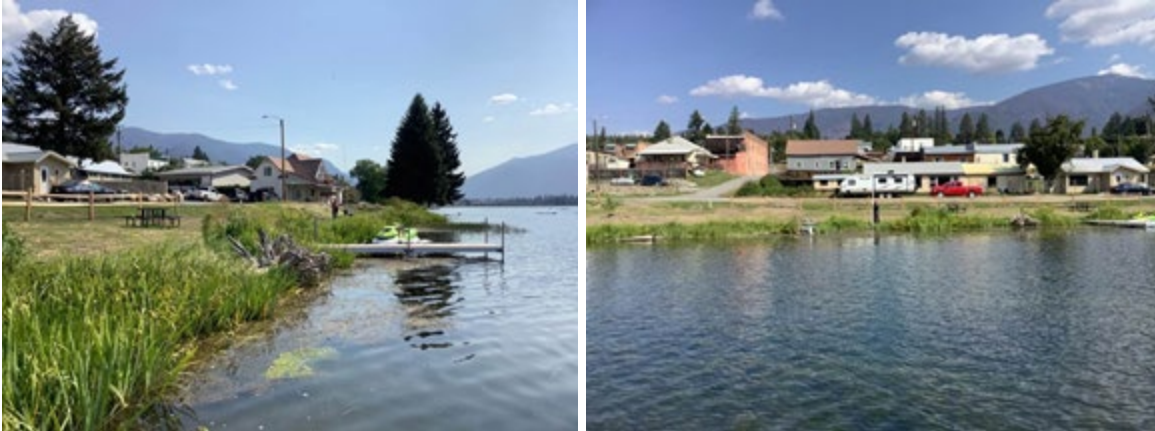
**Photo 3-1. Representative Photos of Shoreline Stability Reference Point #1**

All six monitoring events indicated shoreline erosion was 0 to 10 percent, with minimal erosion observed (closer to 0% than 10%). The only type of erosion noted was rill or gully erosion and

the only cause noted was human-created footpaths to the reservoir's edge. Once created, the footpaths in turn collected and funneled water from rainfall or snowmelt resulting in the rills or gullies. A slight increase in this type of erosion was observed due to increased foot traffic after public recreation improvements (picnic tables, docks, and lawn) were placed within the 300-foot reach between the July 13 and August 6, 2021, monitoring events. Anecdotal evidence suggests little public use occurred in this area before these recreation improvements were erected in July 2021, and more use occurred afterwards.

Bank profile looking upstream from mid-point, and middle 100 feet of the 300-foot reach.

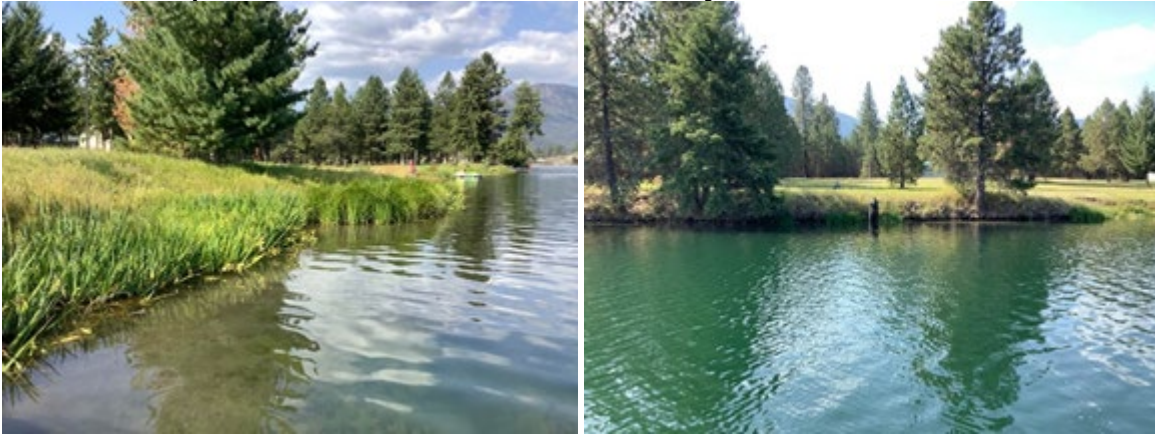
**Photo 3-2. Representative Photos of Shoreline Stability Reference Point #2**

The first four monitoring events indicated 0 to 10 percent erosion and the last two indicated 11 to 30 percent. However, it was determined afterwards that the location of the reference point was shifted upstream by approximately 15 feet between monitoring events four (August 6, 2021) and five (September 1, 2021) which encompassed an area with more erosion. Upon review of the reference point photos, it was determined that erosion remained in that 0 to 10 percent range if the shift had not occurred. The most common type of observed erosion was bank undercutting about 1 to 2 feet tall and 0.5 to 1 foot deep with the cause of this erosion attributable to spring runoff. Increase in the density of vegetation through the summer growing season protected the bank from further erosion from wave action. A less common type of observed erosion was rill or gully erosion caused by a footpath created by human traffic and perhaps accentuated by wildlife use.

Bank profile looking downstream from mid-point, and upper 100 feet of the 300-foot reach.

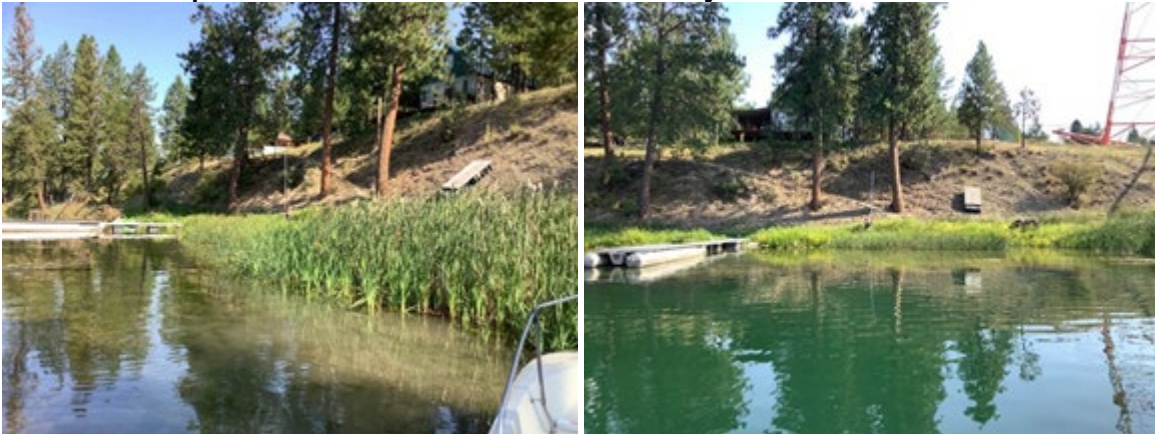
**Photo 3-3. Representative Photos of Shoreline Stability Reference Point #3.**

All six monitoring events indicated 0 to 10 percent erosion. Rill or gully erosion caused by a footpath was observed and became exacerbated by the placement of a wood railing along the trail by a third party. The wood railing channeled water from runoff and irrigation above concentrating the volume, velocity and erosive power of the water. Surface runoff from the pipeline tower pad located at the top of this reference point also caused some rill or gully erosion.

Bank profile looking downstream from mid-point, and lower 100 feet of the 300-foot reach.

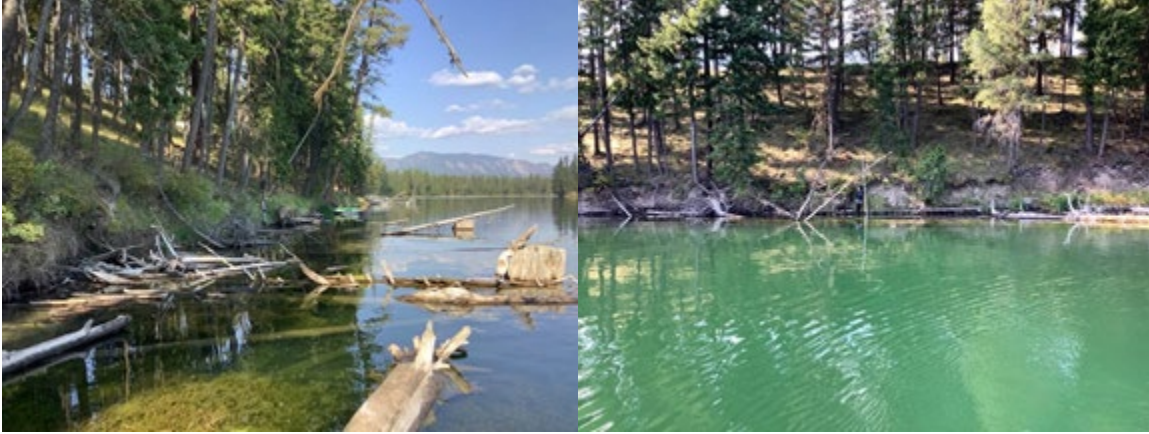
**Photo 3-4. Representative Photos of Shoreline Stability Reference Point #4**

Two of the six monitoring events indicated 31 to 50 percent erosion, one indicated 51 to 70 percent erosion and three indicated 71 to 100 percent erosion. Review of the photos from all six monitoring events suggests the variability in the percentages had more to do with the data collection challenges such as changes in shoreline vegetation. This reference site falls within a geology more susceptible to erosion due to the fine-grained soils and relatively steep bank angles. These conditions create a dynamic shoreline, a lot of woody debris, and falling trees (including 1 that fell during the Operations Study). The two most common types of erosion are bank slumping and undercutting. Slumping averaged about 7 feet tall and 3 feet deep and undercutting averaged about 4 feet tall and 2 feet deep. The major cause of the slumping and undercutting was attributed to spring runoff, but the periodic falling of trees and associated bank damage is also a likely cause.

Visits to this reference point provided valuable observations regarding boat wakes and their impact on shoreline stability. A few boats passed by while conducting monitoring at this reference point allowing for their wakes to be observed. Where the wakes encountered woody materials (e.g., stumps and logs) the wake tended to be quickly dissipated with little, if any, of the wake reaching the shore. Likewise, when wakes encountered emergent aquatic vegetation. For submergent aquatic vegetation, there was some dissipation, but much less. Boat wakes did cause the sediment to be stirred up along the shoreline creating some turbidity about a foot out from the shore. However, this was just resuspension of deposited sediment next to the shore *versus* erosion of upland soils.

Bank profile looking downstream from mid-point, and upper 100 feet of the 300-foot reach.

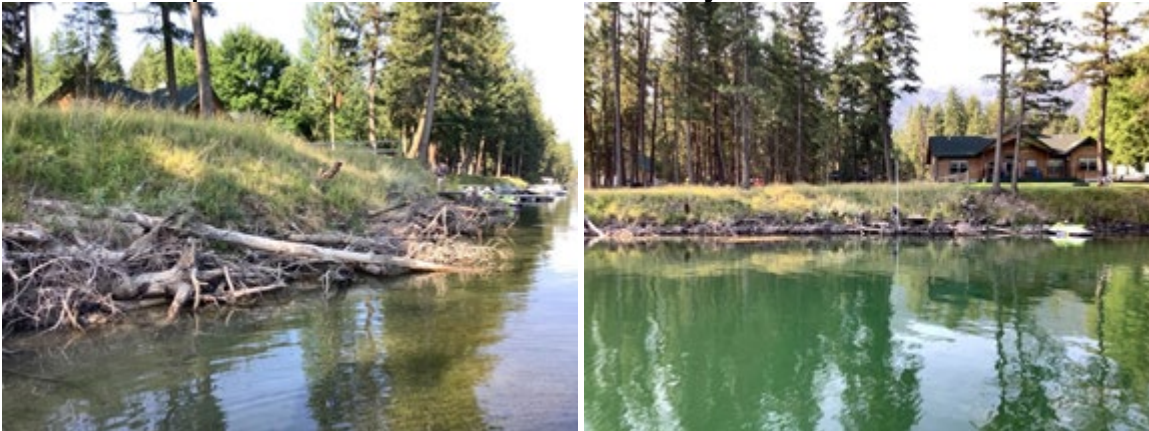
**Photo 3-5. Representative Photos of Shoreline Stability Reference Point #5**

This reference point mostly consists of a 200-foot-long shoreline stabilization project (pilot project) completed by the adjacent landowner and NorthWestern in 2020 as a pilot project to test a bio-engineered shoreline stabilization treatment as an alternative to the commonly-used rock rip-rap. Before the pilot project (**Photo 3-6**) was completed, the shoreline was an 8- to 12-foot-tall eroding vertical bank with little protection from further erosion.

Bank profile looking downstream from mid-point, and lower 100 feet of the 300-foot reach.

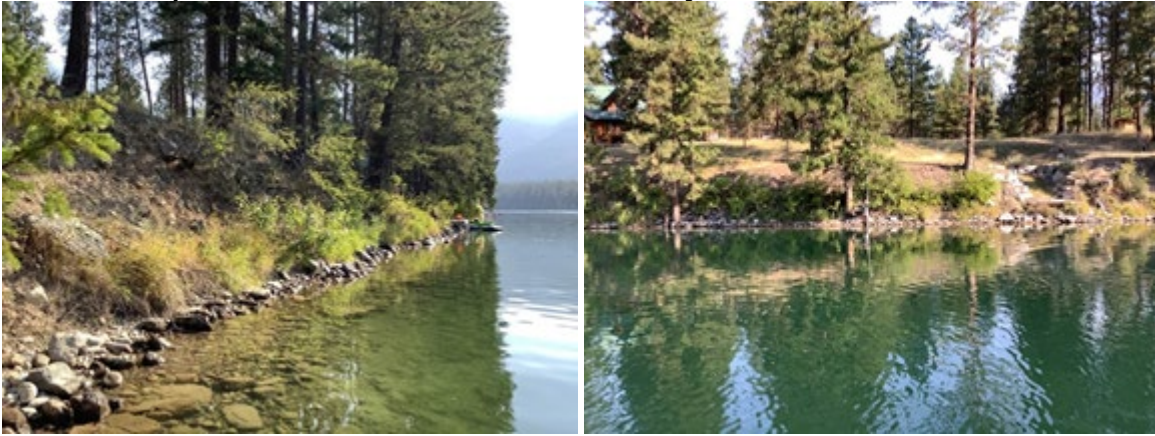
**Photo 3-7. Representative Photos of Shoreline Stability Reference Point #6**

All six monitoring events indicated either 0 to 10 percent or 11 to 30 percent erosion. The most common type of erosion was rill or gully erosion caused by footpaths and removal of native vegetation allowing rain and other runoff to erode soils. However, this reach is a generally very stable land type with a natural rock toe extending into the reservoir creating shoreline conditions resistant to other types of erosion such as undercutting and slumping.

Bank profile looking downstream from mid-point, and lower 100 feet of the 300-foot reach.

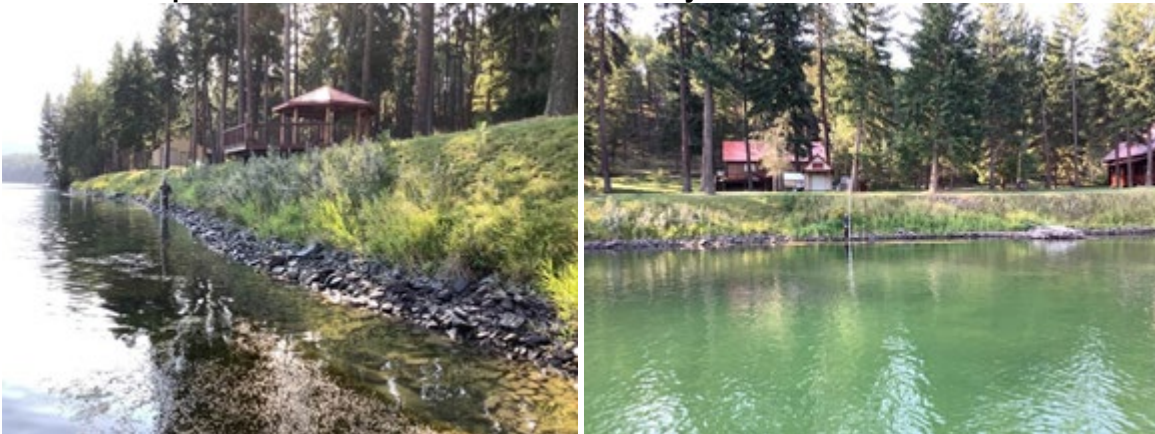
**Photo 3-8. Representative Photos of Shoreline Stability Reference Point #7**

All six monitoring events indicated 0 to 10 percent erosion. There is minor (less than 10 feet of shoreline) undercutting about 1 foot tall and 0.5 foot in depth underneath a short section of the rock toe that was attributed to spring runoff.

Bank profile looking upstream from mid-point, and middle 100 feet of the 300-foot reach.

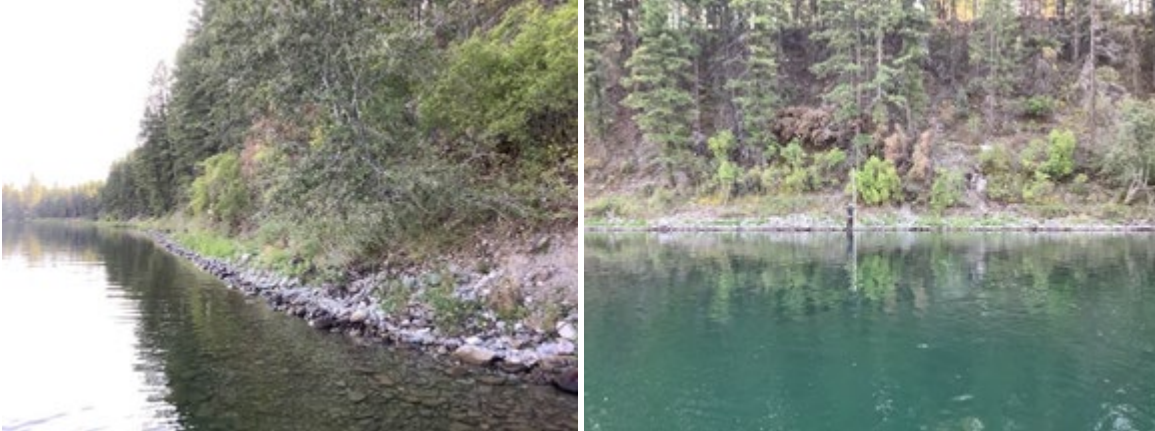
#### Photo 3-9. Representative Photos of Shoreline Stability Reference Point #8

Reference Point #8 is in Land Facet 8(2) which is a bouldery variant, and as noted in NorthWestern (2020), the shoreline erosion in this Land Facet is anomalous because bouldery substrates tend to be more stable. Increased fetch distances may be creating more wave erosion in this Land Facet (NorthWestern 2020).

Five of the six monitoring events indicated 11 to 30 percent erosion and one indicated 0 to 10 percent. This reference point shows a native rock armored shoreline above the water's edge that is resistant to active erosion. Common types of erosion include undercutting and associated slumping were attributed to spring runoff and potential ice scour. Rill or gully erosion was also present which was caused by falling trees further upslope and wildlife trails that in turn caused water to channelize and create erosion.

Bank profile looking upstream from mid-point, and upper 100 feet of the 300-foot reach.

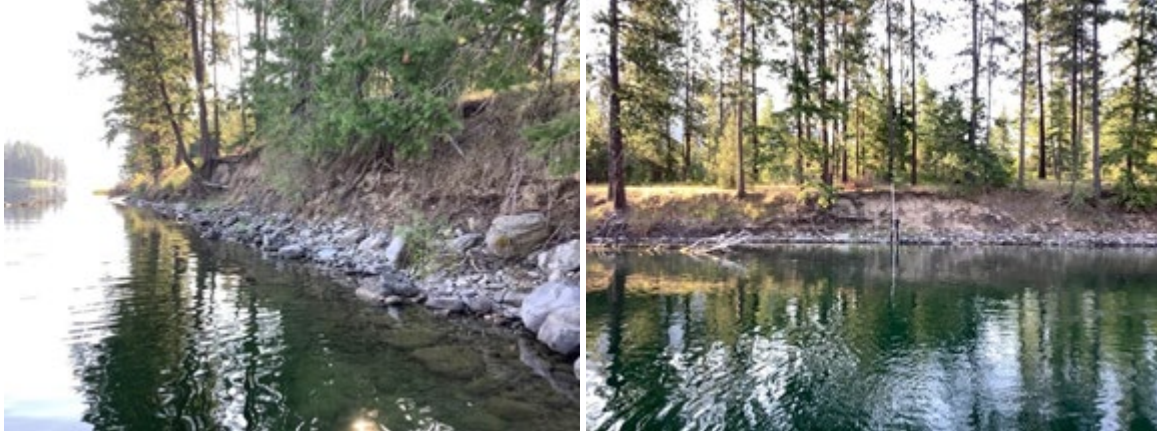
**Photo 3-10. Representative Photos of Shoreline Stability Reference Point #9.**

are attributed to spring runoff and potential ice scour. Water marks and scraped bark on trees (from potential ice scour or spring runoff pushing flood debris against the trees) were observed multiple feet above the full pool level of the reservoir during the monitoring events.

Bank profile looking upstream from mid-point, and upper 100 feet of the 300-foot reach.

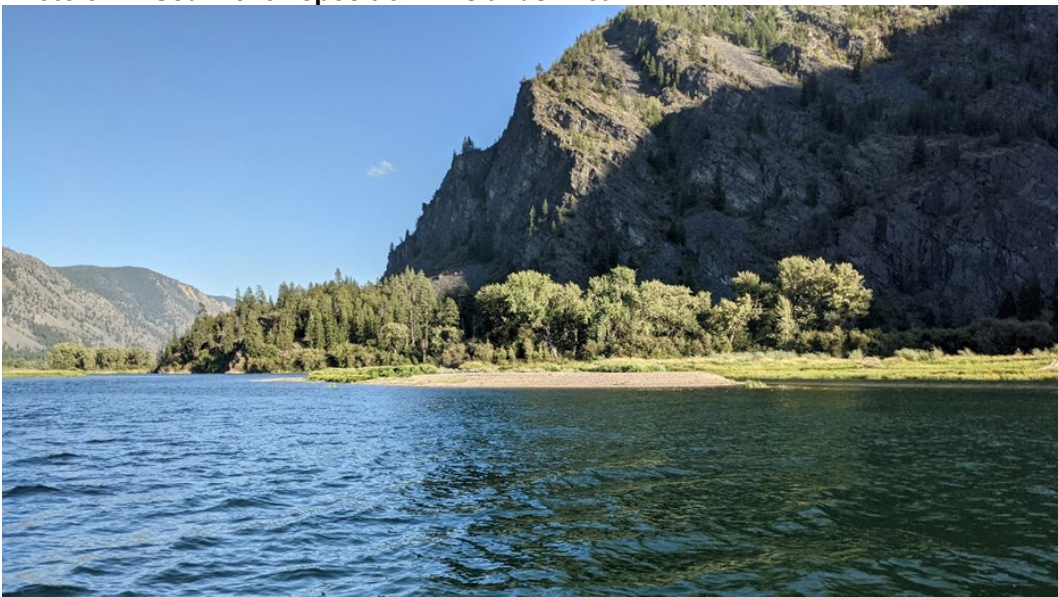
On August 31, 2021, observations were made of shoreline stability from the Thompson River to the upstream end of the Project boundary. This area is more riverine than the area downstream of the Thompson River, and the observations are consistent with riverine conditions. Erosion, deposition, and August water levels well below the high-water mark were all observed. The area around the islands in particular demonstrated active bank sloughing and undercutting (**Photo 3-13**) from spring runoff and perhaps even from lower water flows. Where the shoreline is composed of finely grained material (sands/silts/clay), vertical banks up to 6 feet tall were common, with bank sloughing also common. This shoreline condition existed on both the island shorelines and the mainland shoreline, but more prevalent on the island shorelines since some of the mainland shoreline in this area is bedrock or large rock. The water is shallower in this area, and it is located further away from the City of Thompson Falls and public boat launches, so this area likely gets much less boat traffic than other portions of the reservoir. Erosion in this area is most likely due to ice scour and water current since it is more riverine in nature. Erosion is not the only process that is occurring, however, as areas of deposition were also noted in the islands area (**Photo 3-14**). In essence, the shapes, sizes and locations of the islands are always shifting which would be expected in a normally functioning riverine system.

**Photo 3-14. Sediment Deposition in Islands Area**

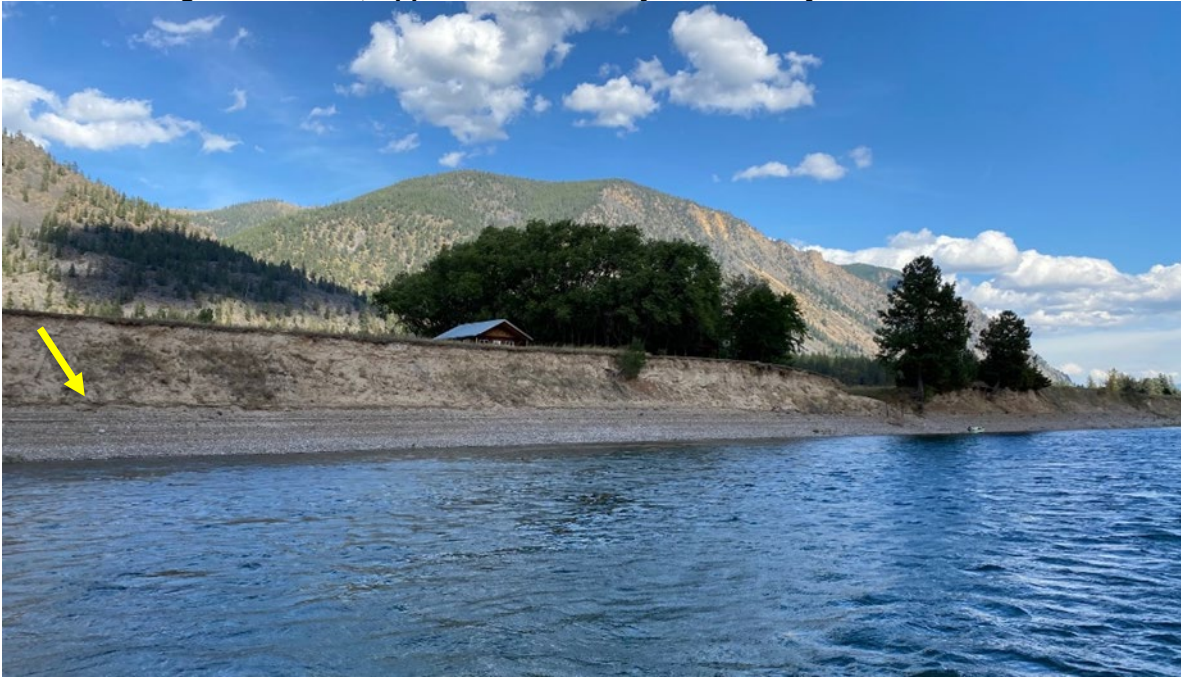
The August 31, 2021, water levels were far below the high-water mark even though the Project was considered to be at full pool (**Photo 3-15**). This suggests Project operations have little if any influence on shoreline stability, erosion and deposition in the area upstream of the islands, and instead spring runoff is the dominant influence in this area.

**Photo 3-15. High-water Mark, Upper End of the Project Boundary. Reservoir at Full Pool**

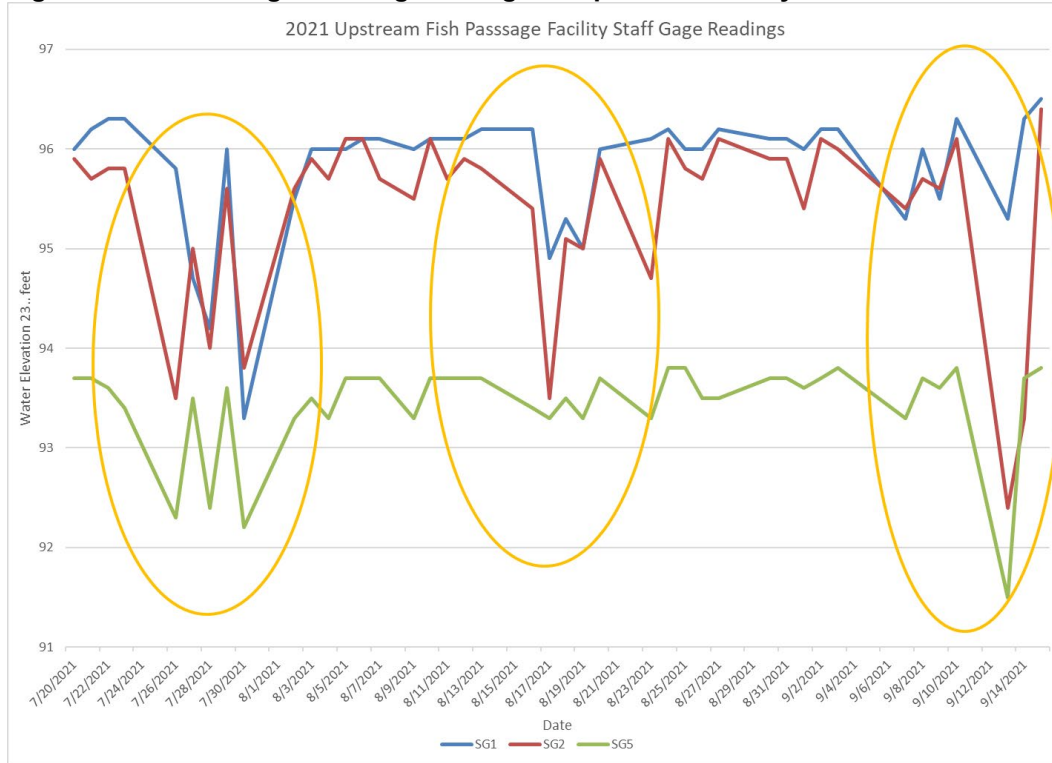
**Figure 3-20. Staff Gage Readings During the Operations Study**

appeared to be different. As the Operations Study continued this trend of dewatering continued with lowered reservoir elevations. **Figure 3-20** shows the daily elevations at the ladder exit or reservoir elevation (SG1) and in Pool 48 (SG2) and Pool 45 (SG5) during the three phases of the Operations Study. Water depths within the fish ladder followed similar patterns as the reservoir elevation throughout the Operations Study.

Three phases of the Operations Study are circled and show water level changes within the ladder and corresponding reservoir elevation.

When the reservoir elevation was 2.3 feet down (2,394.2 feet) the fish passage facility began to have operating issues. The HVJ slowed down considerably and there was reduced water being fed to this feature. The fish sampling loop was inoperable due to the lack of water to fill the fish lift and anesthetizing tank. Pumps were shut off as they were drained, and the entire fish passage facility lacked sufficient flow and water to effectively capture fish.

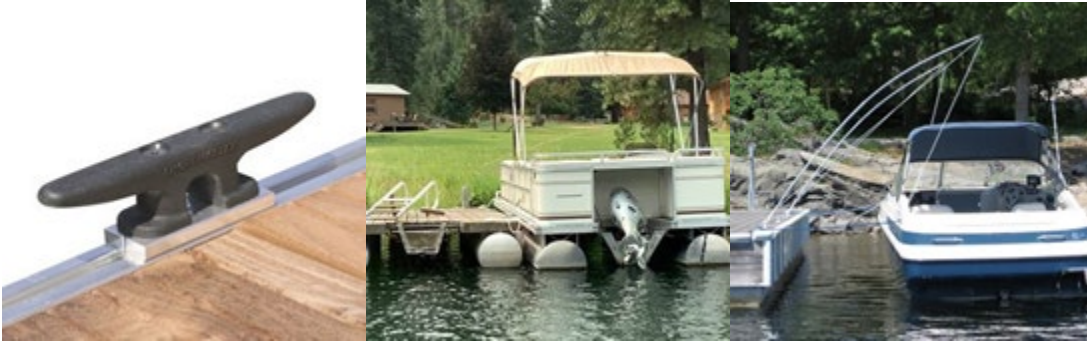
**Photo 3-23. Images of Cleat, Boat Tied to cleats, and Boat Secured with Whips**

Boats tied to cleats on stationary docks may be impacted when the water level decreases if they are tightly tied to the dock and there is not enough slack in the rope to allow the boat to remain floating as the water recedes. Boats tied with boat whips are able to move with the water level while remaining securely fastened to the dock. When cleat-tied boats do remain floating the distance between the top of the dock and the boat increases and it may become difficult to access the boat from the dock due to the vertical drop. Also, boats tied closely to stationary docks can become pinned under the dock as the water levels rise to full pool (**Photo 3-24**).

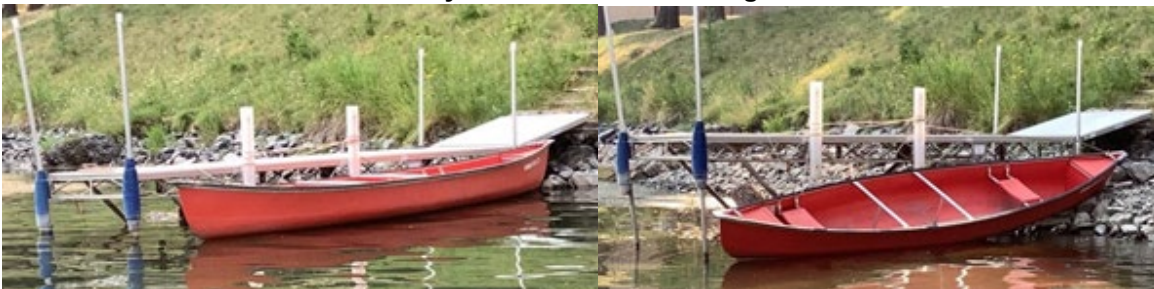
**Photo 3-24. Boats Tied to Stationary Docks with Fluctuating Water Levels**

Canoe tied to stationary dock at full pool and -2.0 ft reservoir elevation.

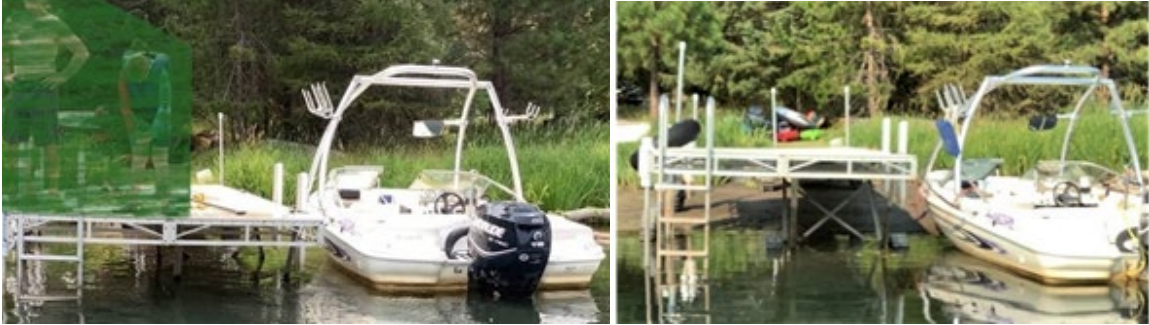
Increased distance between dock and boat resulting from decreased reservoir elevation.

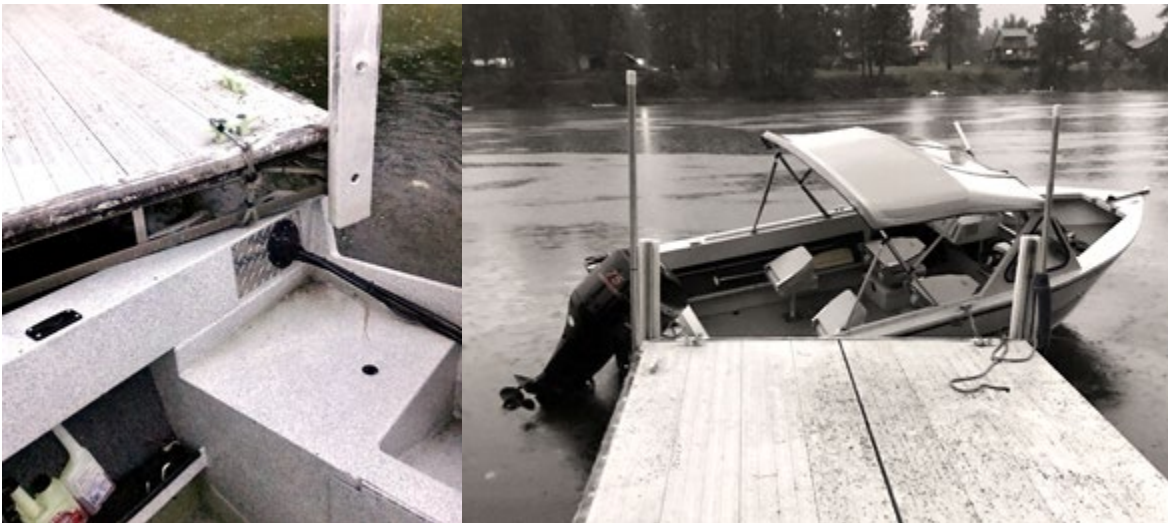
Boat pinned beneath stationary dock when water level rose to full pool.

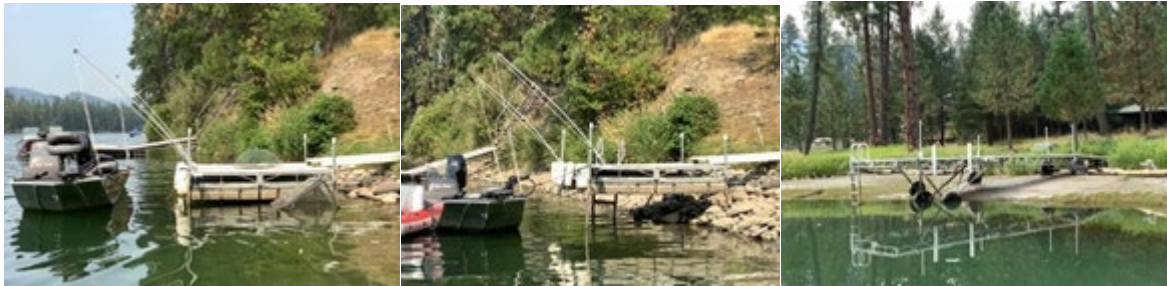
**Photo 3-25. Stationary Docks at Full Pool and Lower Water Elevations**

In all, the water reached about half of the stationary docks at 2.5 feet below full pool but was generally too shallow to provide good waterway access. The other half of stationary docks became dewatered at elevations of 1.5 and 2.0 feet below full pool. While this dewatering did not impact the dock structures, it impacted recreation by preventing access to the waterway from those docks.

North shoreline stationary dock with boat whips at full pool and -2.0 feet elevation, and south shoreline stationary dock mostly dewatered at -2.5 feet elevation.

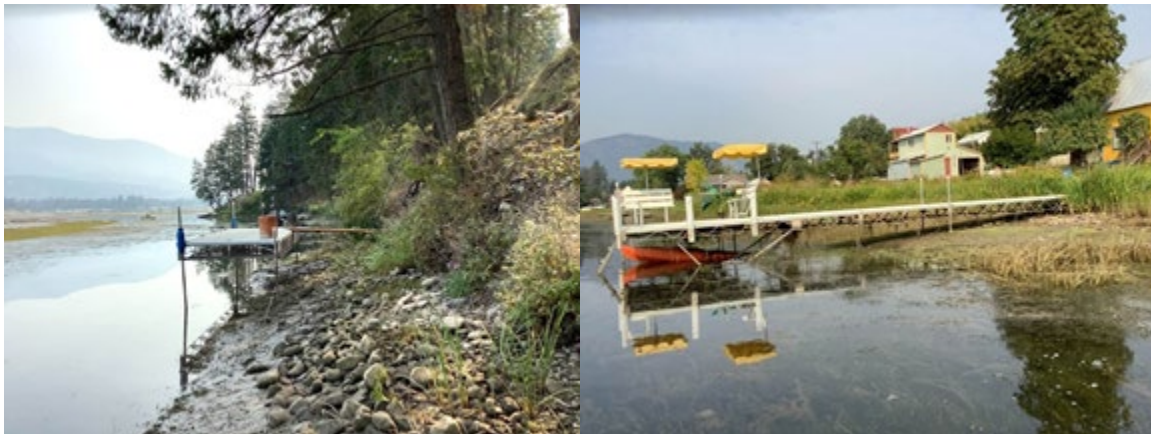
South shoreline main reservoir stationary dock North shoreline main reservoir stationary dock mostly dewatered at -2.5 feet elevation with aquatic vegetation at -2.5 feet elevation.

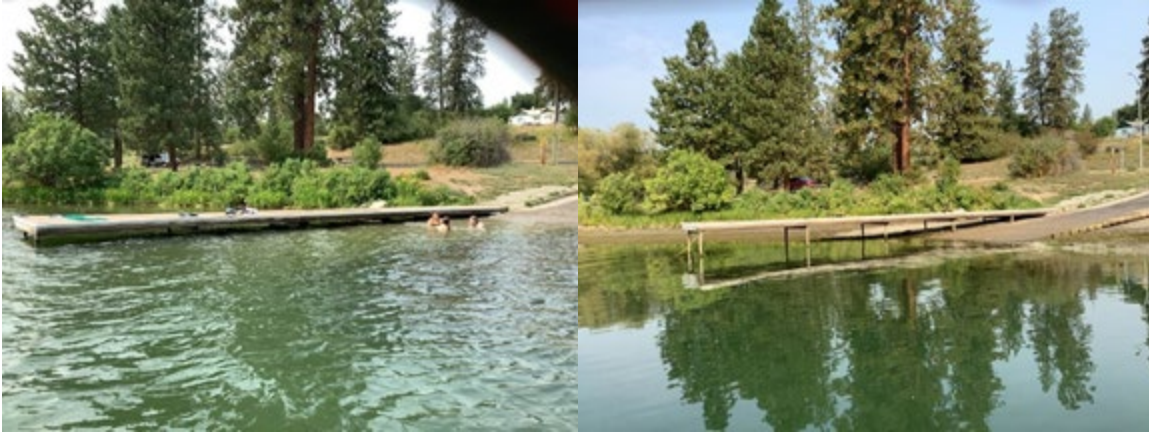
Wild Goose Landing Park. This dock was unaffected by changing reservoir elevations, though access to the water was challenging at reservoir elevations beyond 1.5 ft below full pool (**Photo 3-25**).

Wild Goose Landing stationary boat launching dock, north shore main reservoir, at full pool and -2.5 feet elevation.

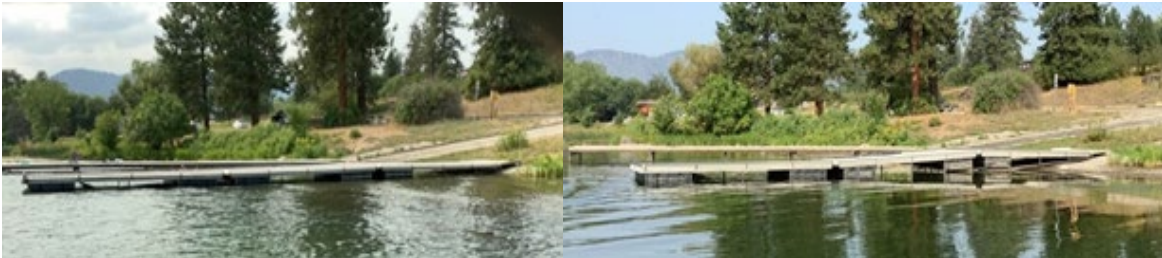
#### Photos 3-26. Floating Docks at Full Pool and -1.5 Feet Elevation

Wild Goose Landing floating dock, north shore main reservoir, at full pool and -1.5 feet elevation.

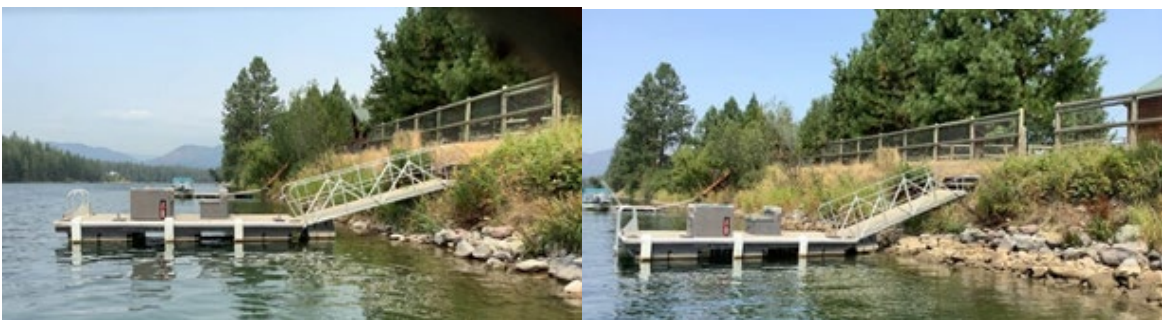
North shoreline floating dock at full pool and with steep gangway angle at -1.5 feet elevation.

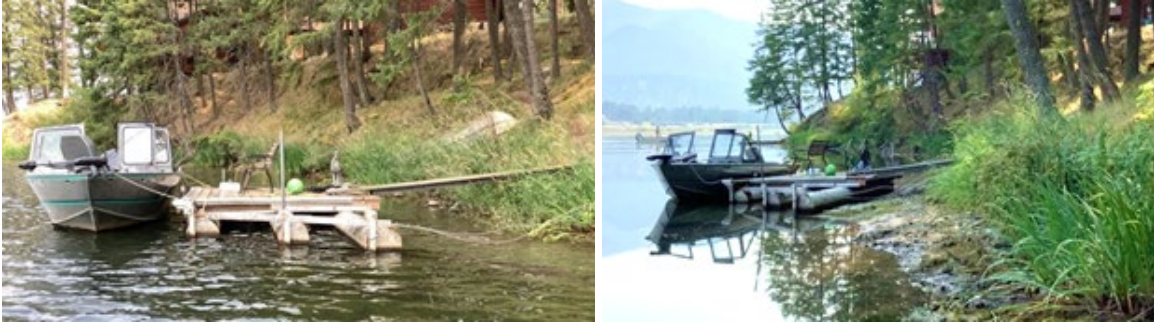
South shoreline main reservoir floating dock at full pool and mostly dewatered at -1.5 feet elevation.

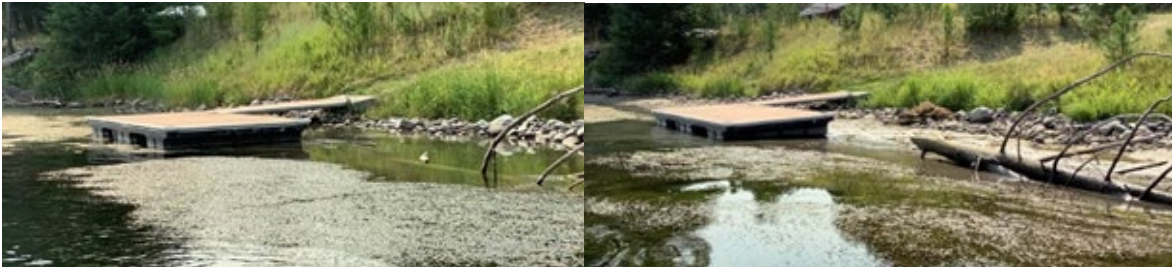
South shoreline floating dock at full pool and -1.5 feet elevation.

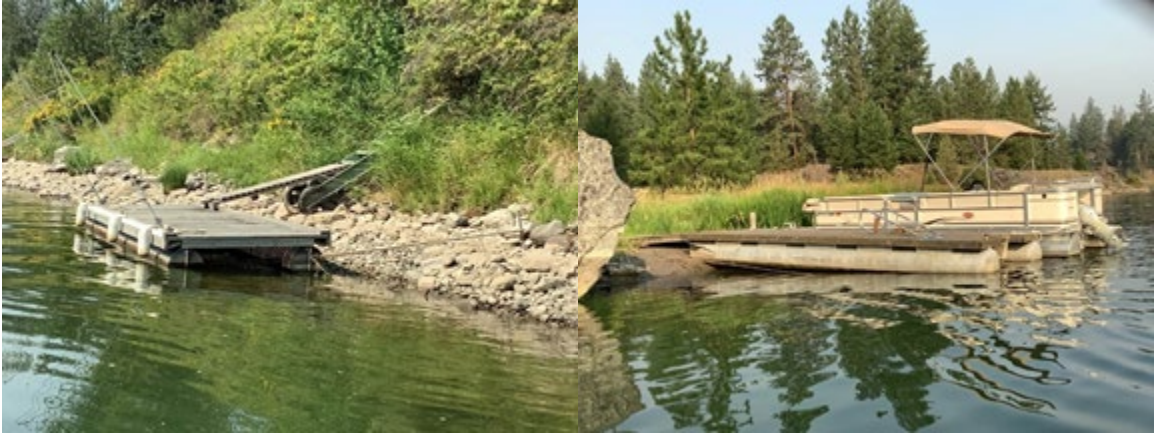
**Photos 3-27. Floating Docks at Full Pool and Lower Water Elevations**

Upper north shore floating dock and south shore floating dock near Steamboat Island at -2.0 feet elevation.

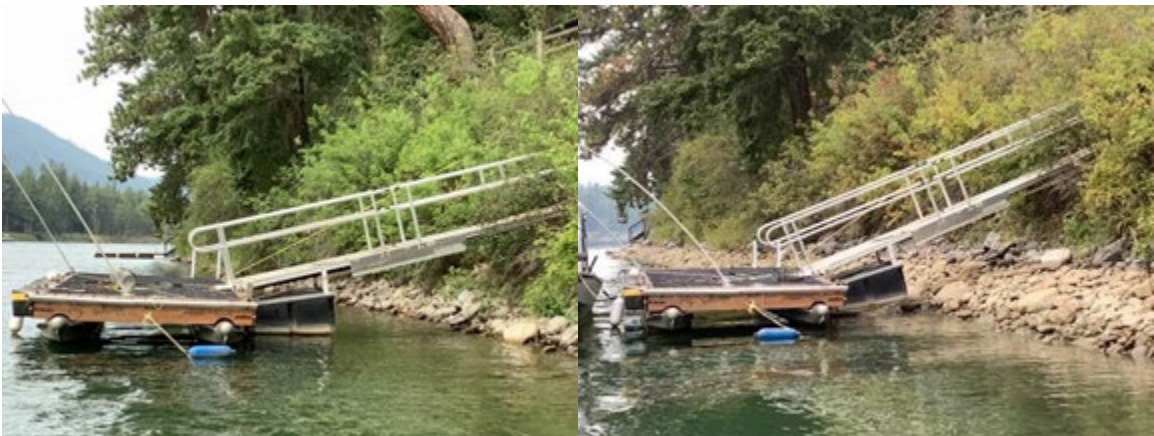
North shore floating dock at full pool and with very steep gangway at -2.5 feet elevation.

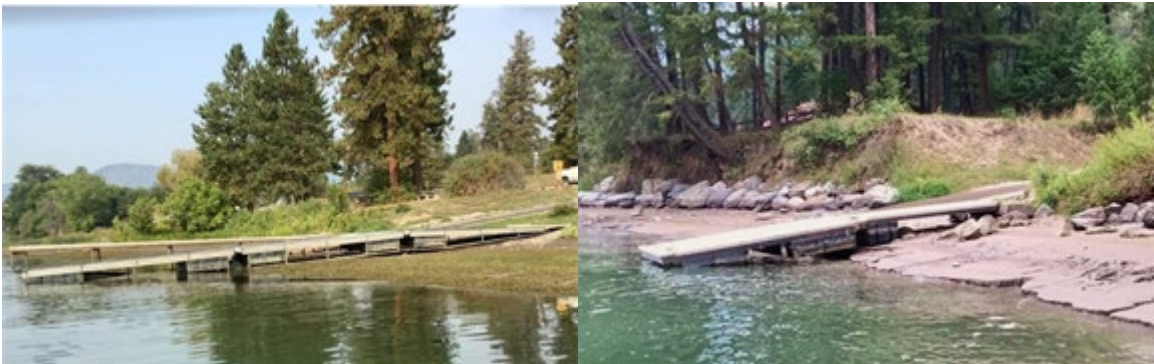
Publicly accessible floating docks are located at Cherry Creek and Wild Goose Landing Park (**Photos 3-27**). At Cherry Creek, the floating dock remained usable at elevations down to 1.5 feet below full pool, though the gangway and near-shore end of the dock were grounded. As elevations dropped below that level, the dock became steeply angled and inaccessible as the end of dock remained floating while the near-shore portion was grounded.

The floating dock at Wild Goose Landing Park remained accessible at all elevations though usability was reduced at the lowest elevations. The dock became angled at low elevations, offered access to little water at the lowest reservoir elevation, and the accessible water near the dock was inundated with aquatic vegetation.

Wild Goose Landing (north shoreline main reservoir) and Cherry Creek Boat Launch (south shoreline) mostly grounded docks at -2.5 feet elevation.

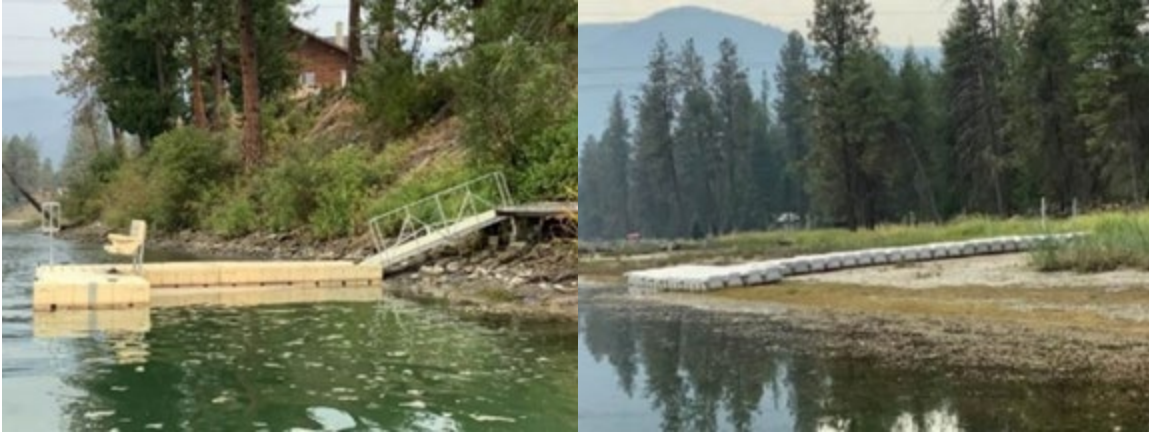
North shoreline and south shoreline floating EZ docks located opposite each other about a half mile upstream of Steamboat Island at -2.5 feet elevation. North shore dock is floating, south shore dock is completely grounded.

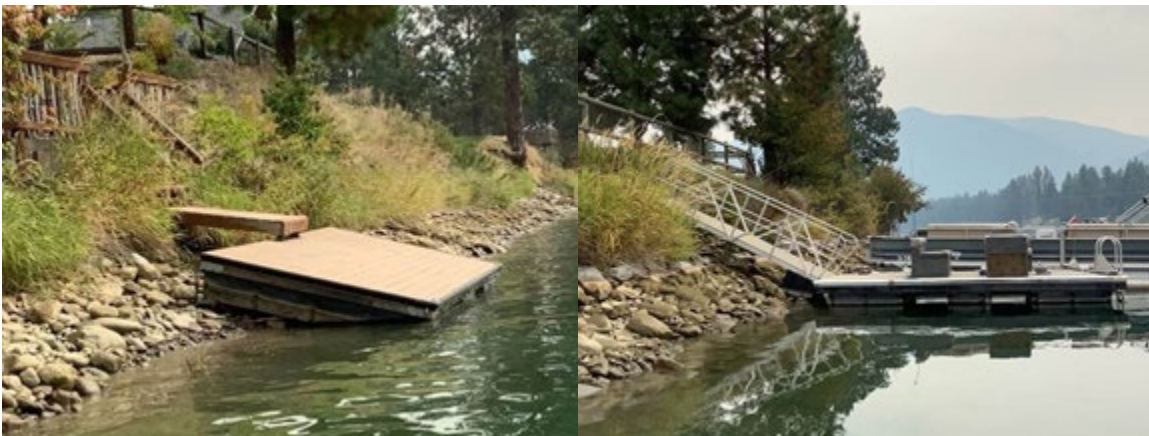
North shoreline docks aligned parallel (left) and perpendicular (right) to shoreline at -2.5 feet elevation. Parallel dock with short ramp is grounded, perpendicular dock with longer gangway is floating.

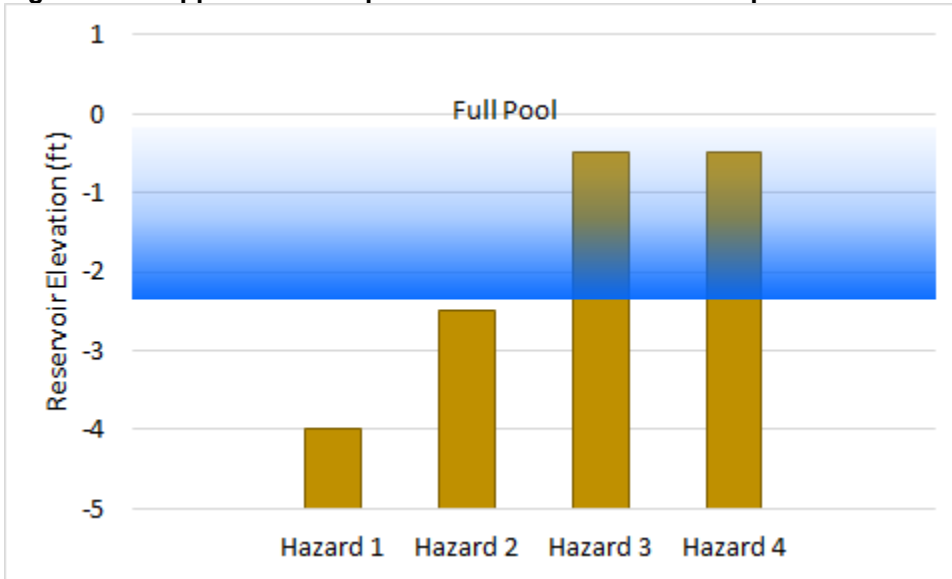
**Figure 3-25. Approximate Depth of Hazardous Rock Outcrops and Reservoir Elevation**

The depths of these hazards were monitored during each half-foot static hold to determine how risk to public safety changes with water elevations in these four locations. Hazards 1 and 2 were submerged at full pool to depths of 4 and 2.5 feet respectively (**Figure 3-25**). As the reservoir elevation was lowered in response to increased generation, these hazards approached the surface. Hazard 1 remained submerged but high enough in the water column to pose a risk to watercraft at only 1.5 feet deep after the reservoir reached an elevation of 2.5 feet below full pool. Hazard 2 became visible when the reservoir elevation was down 2.5 feet and was within about 1 foot of the surface when the reservoir was down 1.5 feet. Since these hazards moved higher into the water column the risk of contact with these hazards increased as the reservoir elevation was lowered.

Hazards 3 and 4 were submerged 0.5 foot at full pool and became visible as the reservoir level was lowered. As such, they also became more visible at lower reservoir elevations and, therefore, the risk of contact associated with these hazards decreased as the reservoir elevation was lowered due to their increased visibility to recreationists. Also, these hazards, along with Hazard 2, are relatively close to shore (about 50-75 feet) so it is less likely that boats moving through the area at high rates of speed would do so in that close of a proximity to the shoreline, which reduced the chance of contact. Hazard 1, however, is about 100 feet off shore and closer to the deeper channel so contact is more likely.

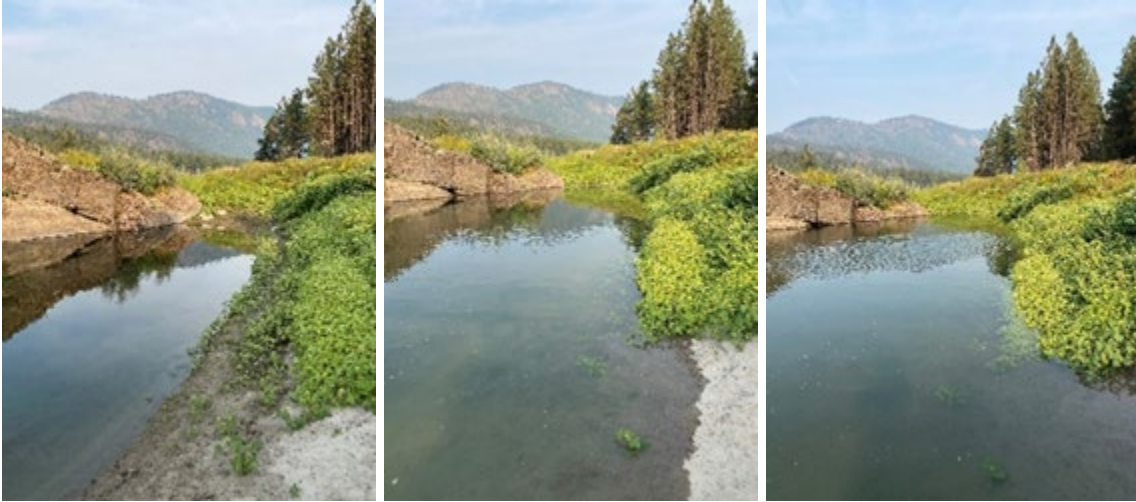
**Photo 3-32. Elevation Changes at 15-minute Intervals during Phase 3**

Water elevation changes were noticeable in real-time at Sandy Beach during the testing. The swimming hole at the site is relatively small. The shoreline meets a rock outcrop on the inland portion of the site and a large rock outcrop and gravel bar define the outer edge to create a calm swimming hole. As the water level rose, it moved noticeably further up the shoreline (**Photo 3-32**) and rock outcrop.

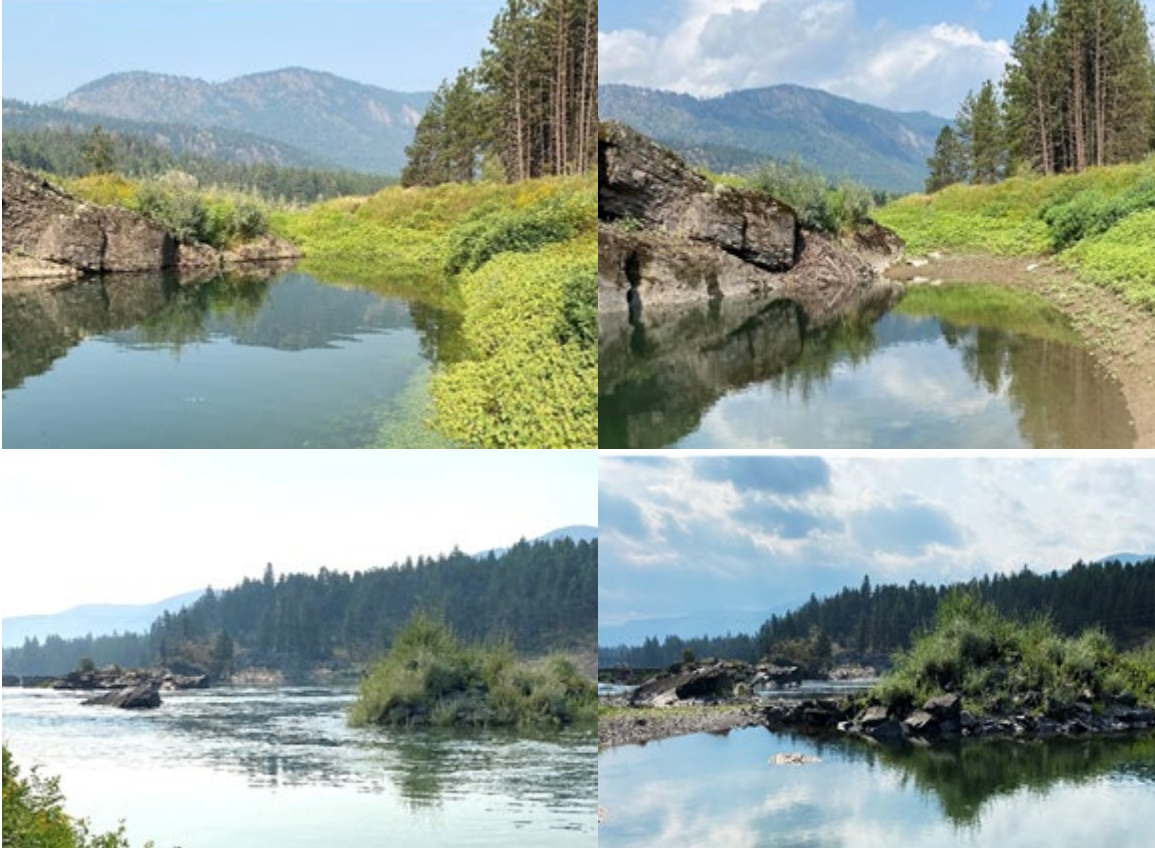
**Photos 3-33. Upper and Lower Limits of Water Elevations at Sandy Beach at Shoreline and Beach Area and Outer Bounds of Swimming Hole**

Photos illustrate the limits of the elevation changes throughout all three Operations Study phases, which was about 3.5 feet total difference in depth (**Photos 3-33**). Though the rising water was noticeable during the study phases, the resulting current was minimal as flows into the swimming hole are attenuated by a gravel bar, a rocky embankment and an outcrop.
