**Thompson Falls Hydroelectric Project
FERC Project No. 1869
Final Study Report – Operations Study**

May 2023

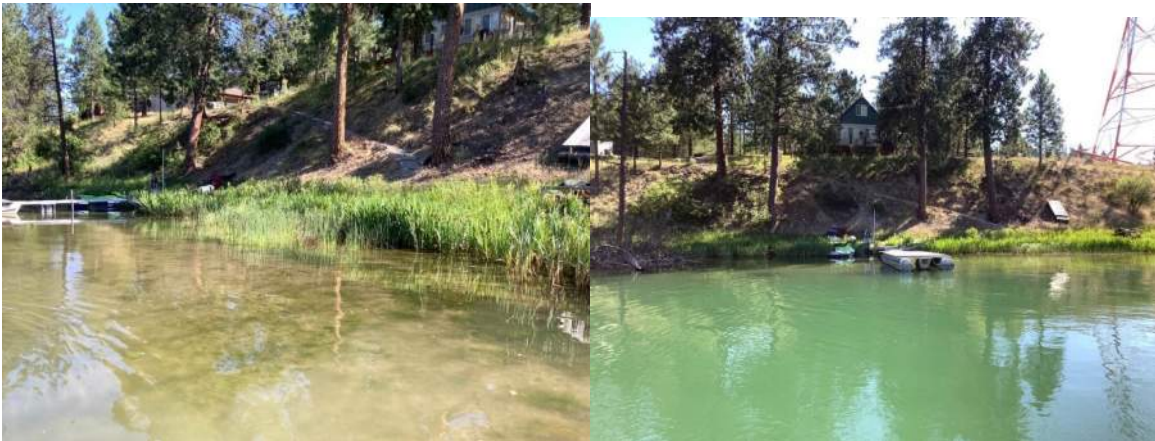
Photo 3-3. Representative Photos of Shoreline Stability Reference Point #3.

Both monitoring events indicated 0 to 10 percent erosion. This is no change from the six monitoring events completed in the first study season (NorthWestern 2022). Rill or gully erosion caused by a footpath, and surface runoff from the pipeline tower pad located at the top of this reference point was determined to be the cause of the rill or gully erosion.

Bank profile looking downstream from mid-point, and lower 100 feet of the 300-foot reach.

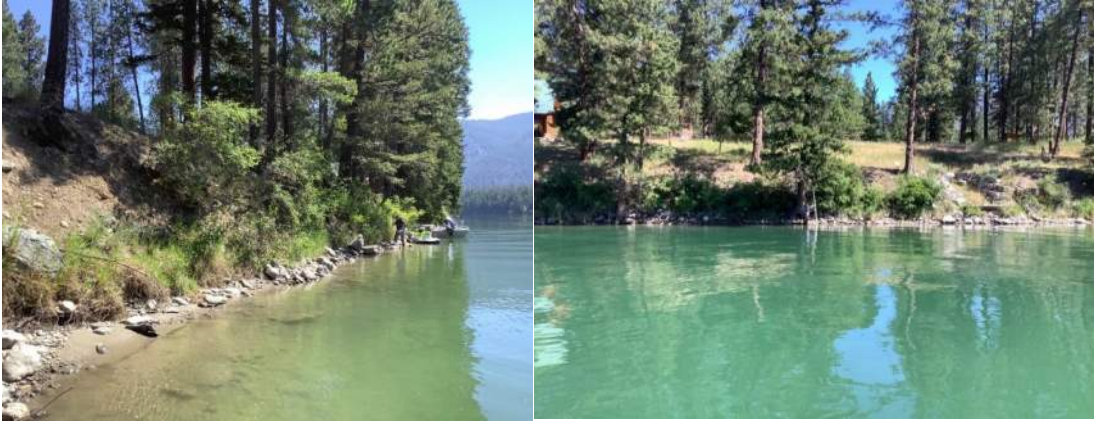
Photo 3-7. Representative Photos of Shoreline Stability Reference Point #6

The first monitoring event indicated 0 to 10 percent erosion and the second monitoring event 11 to 30 percent erosion, similar to the results noted in 2021. The most common type of erosion was rill or gully erosion caused by footpaths and removal of native vegetation allowing rain and other runoff to erode soils. The increase in erosion between the two monitoring events is thought to be due to a significant rain event of 1.7 inches on August 21, 2022. This reference point has a steeper slope with little vegetation cover, making it more susceptible to erosion during this rain event, and more susceptible than the other eight reference points. However, it is still a very stable land type with a natural rock toe extending into the reservoir creating shoreline conditions resistant to other types of erosion such as undercutting and slumping.

Bank profile looking upstream from mid-point, and lower 100 feet of the 300-foot reach.

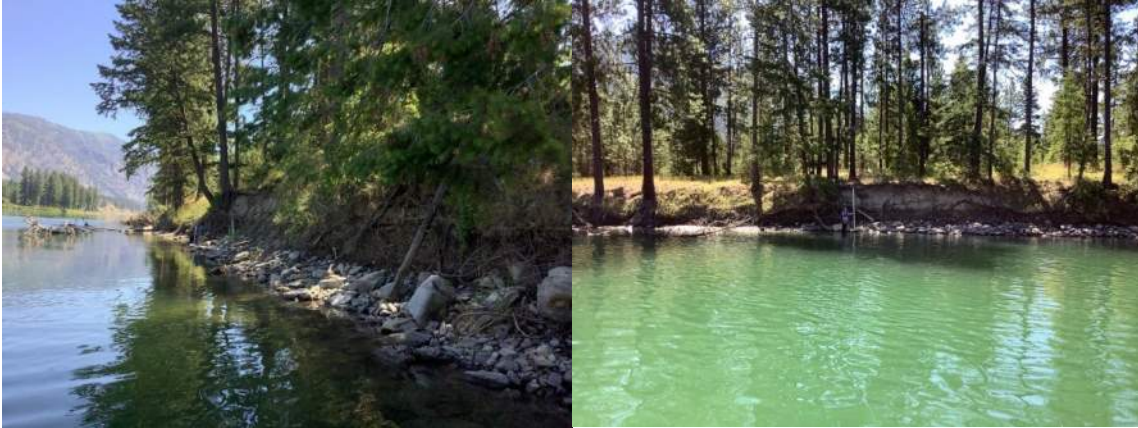
Photo 3-10. Representative Photos of Shoreline Stability Reference Point #9.

undercutting up to a few feet in depth. The causes of erosion are attributed to spring runoff and potential ice scour. Water marks and scraped bark on trees (from potential ice scour or spring runoff pushing flood debris against the trees) were observed multiple feet above the full pool level of the reservoir during the monitoring events.

Bank profile looking upstream from mid-point, and upper 100 feet of the 300-foot reach.

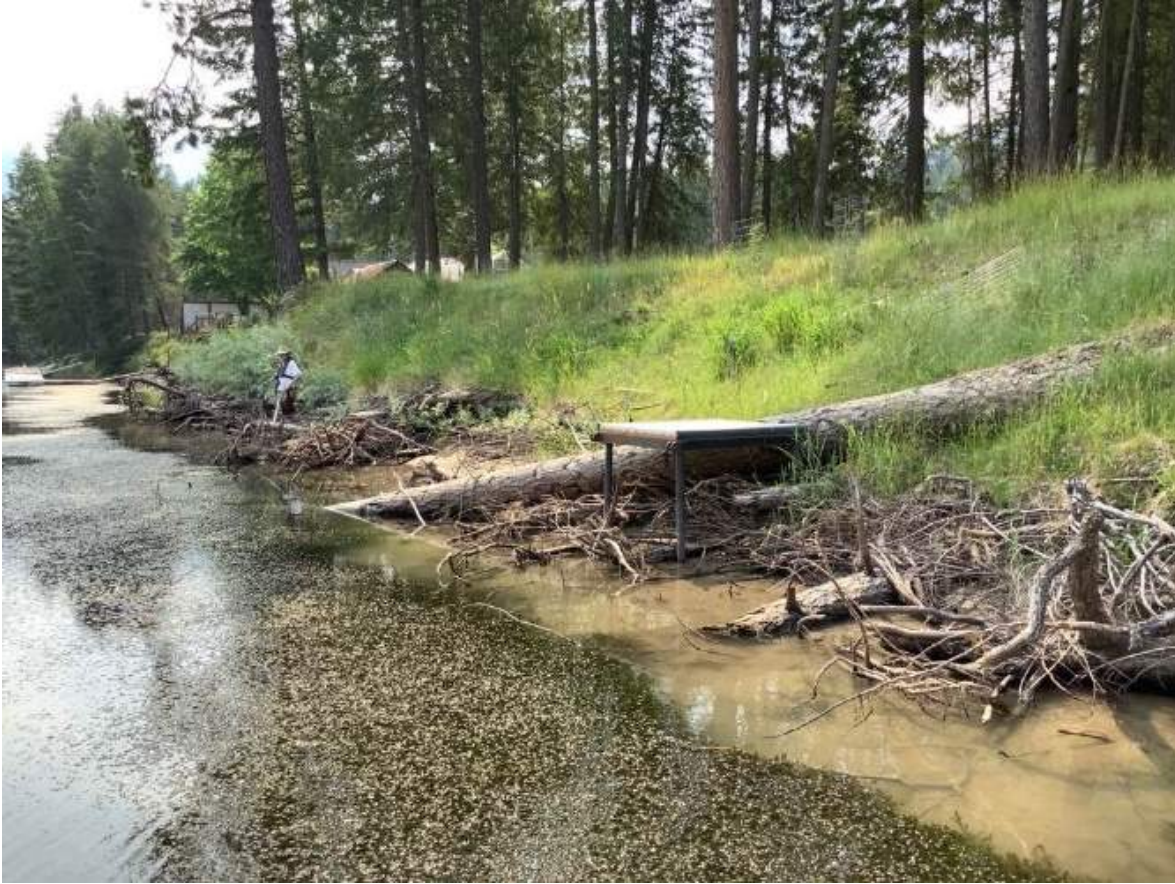
Photo 3-11. Reference Point #5 July 13, 2021.

The spring and early summer of 2022 were unseasonably cool and spring runoff was delayed and prolonged. In the 2021 study season, June 20 was the last day that NorthWestern spilled water at the dam, whereas in 2022 that date was July 20, a full month later. These conditions appear to have delayed aquatic vegetative growth in 2022, in particular submergent aquatic vegetation, as compared with the 2021 study season. For example, at Reference Point #5, the July 13, 2021 monitoring data indicate 91 to 100 percent aquatic vegetation, whereas the July 20, 2022 monitoring data indicate 0 to 10 percent aquatic vegetation (**Photos 3-11 and 3-12**). Another example is Reference Point #7 where aquatic vegetation was 0 to 10 percent in 2022 and 61 to 70 percent in 2021 on those same dates. **Photos 3-13 and 3-14** are of reference points #5 and #7 on those two dates. In the 2021 photos, dense beds of submergent aquatic vegetation can be seen, whereas in 2022 they were more or less not present.

At Reference Points #5 and #7, almost all of the aquatic vegetation is the submergent type. Even though the July 20, 2022 data indicate 0 to 10 percent aquatic vegetation present in depths to 4 feet, there was actually a significant amount of submergent aquatic vegetation present at depths greater than 4 feet. As discussed in the Methods *see* Section 2.3.2, 4 feet is the cutoff depth for recording aquatic vegetation data under this study. At the second monitoring event on September 13, 2022, aquatic vegetation was 91 to 100 percent at Reference Point #5 and 81 to 90 percent at Reference Point #7, at depths to 4 feet. The beds of submergent aquatic vegetation had grown and expanded into the shallower water between July 20 and September 13. They had not grown and expanded into the shallower water before July 20, presumably due to the delayed and prolonged runoff which would have created higher volume and current velocities along the shoreline, reducing the potential for submergent aquatic vegetation to become established.

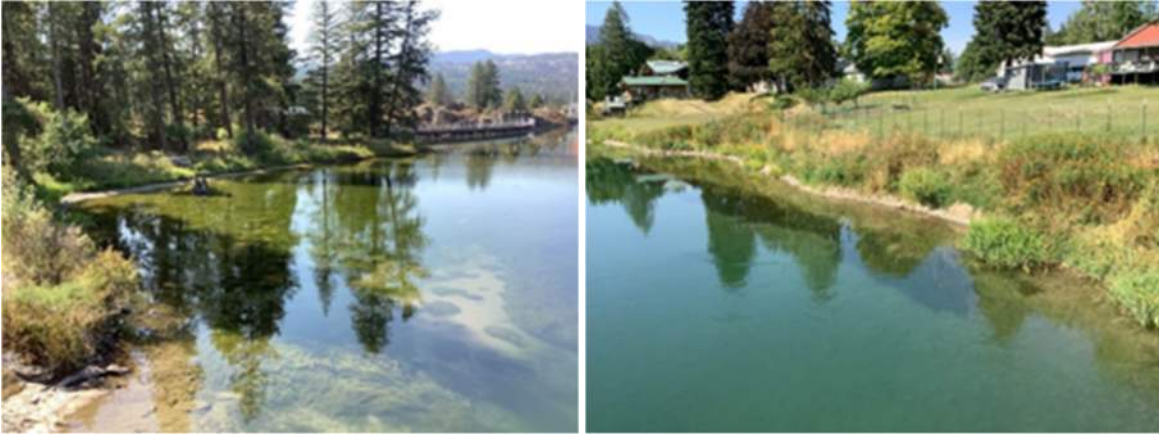
Photos 3-23. Shoreline Areas at 1.0 foot below full pool.

Shoreline areas at Island Park and the north shoreline adjacent to the Gallatin Street Bridge at 1.0 foot below full pool.

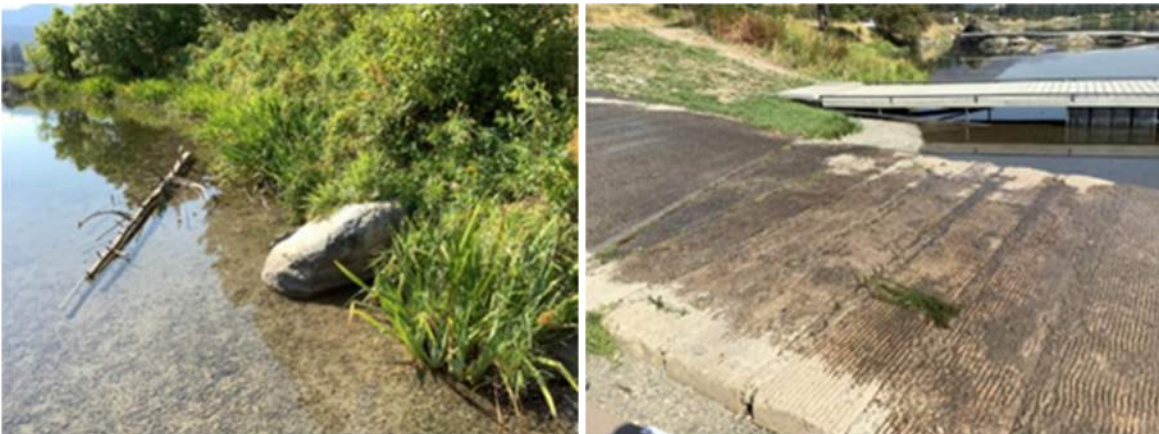
Shoreline areas at Wild Goose Landing Park at 1.0 foot below full pool.

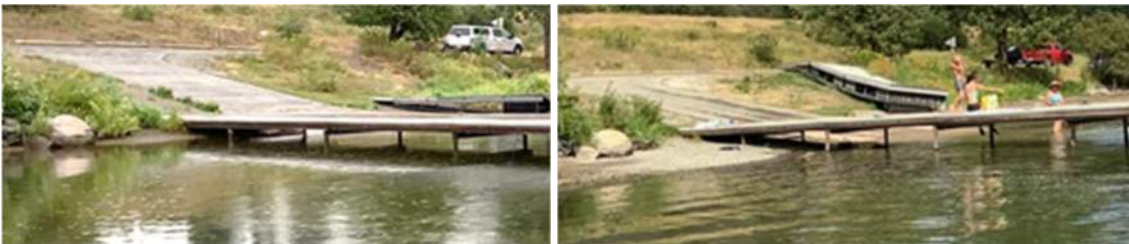
Shoreline areas at Wild Goose Landing Park at 1.0 foot below full pool (left, 2021 photo) and at 1.8 feet below full pool (right, 2022 photo).

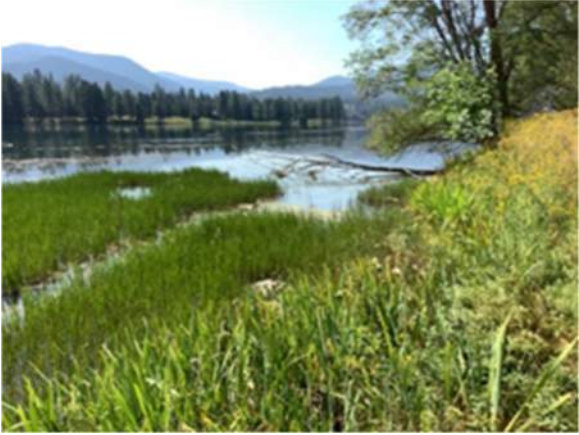
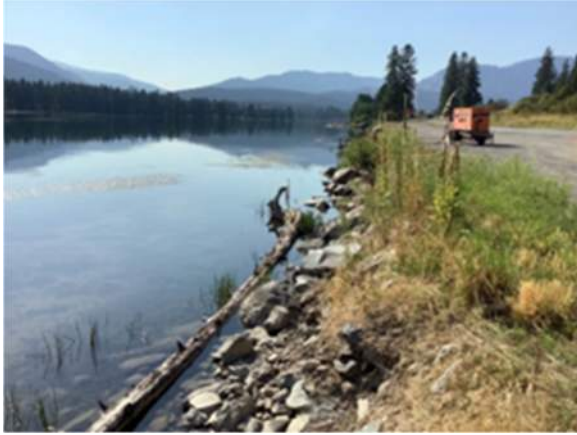
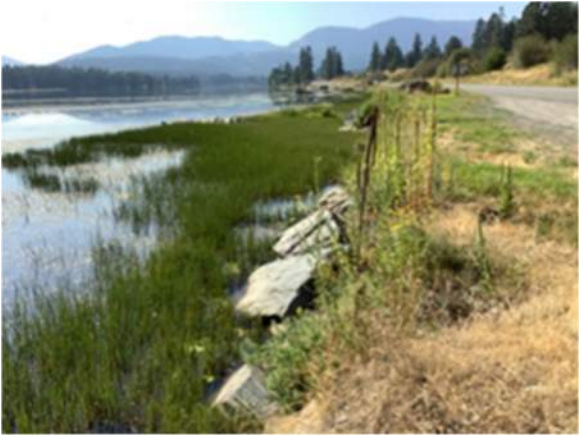
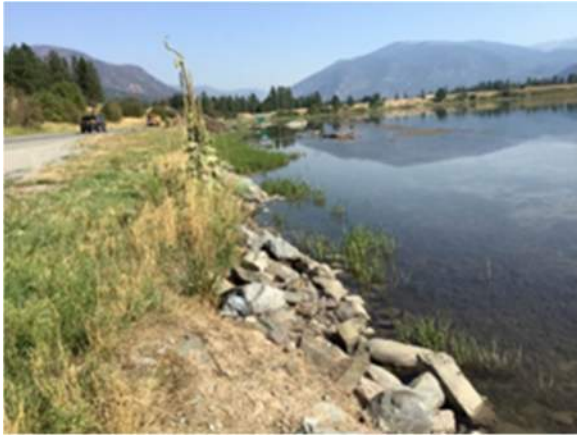
North reservoir shoreline areas downstream of Wild Goose Landing Park (top left) and upstream of Wild Goose Landing Park along the North Shore Dispersed Use Area (top right and bottom photos) at 1.0 foot below full pool.

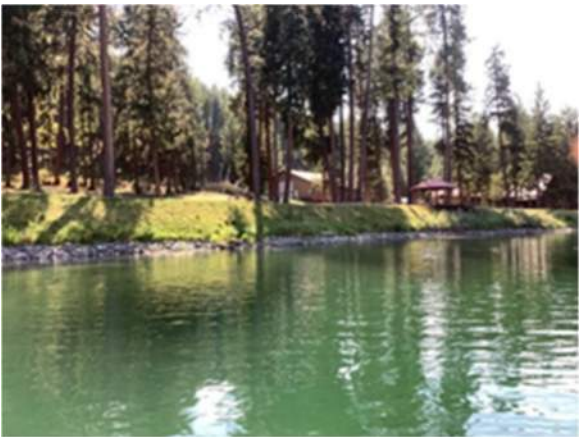
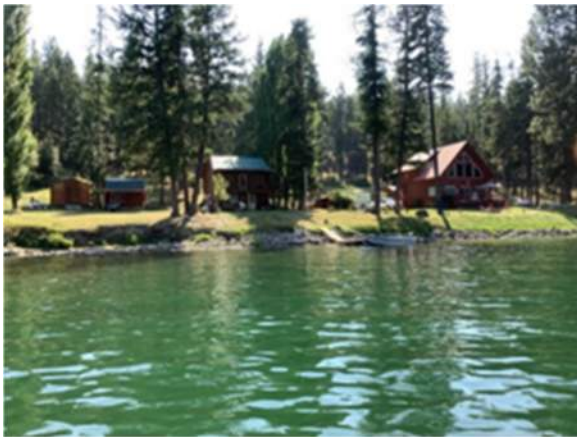
South shoreline areas upstream of Steamboat Island at 1.0 foot below full pool.

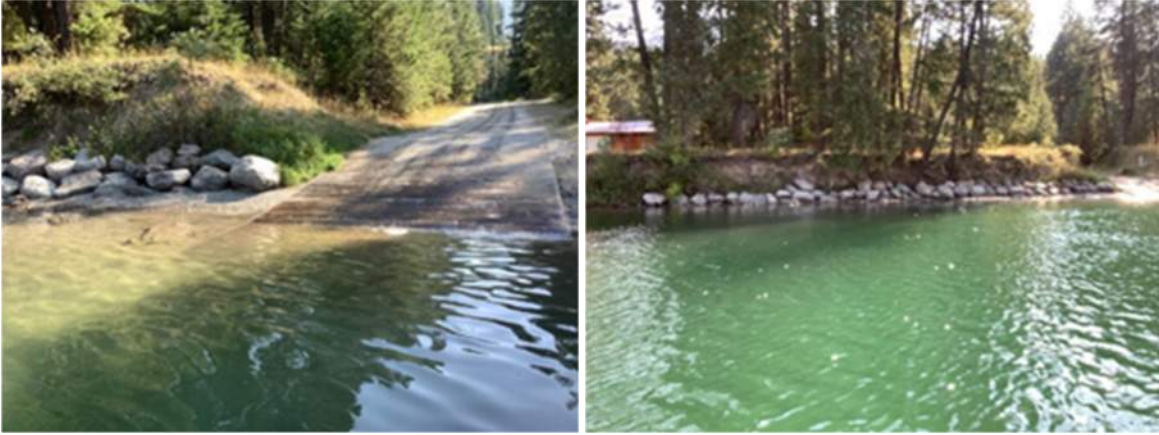
South shoreline area at Cherry Creek Boat Launch (public dock) at 1.0 foot below full pool.

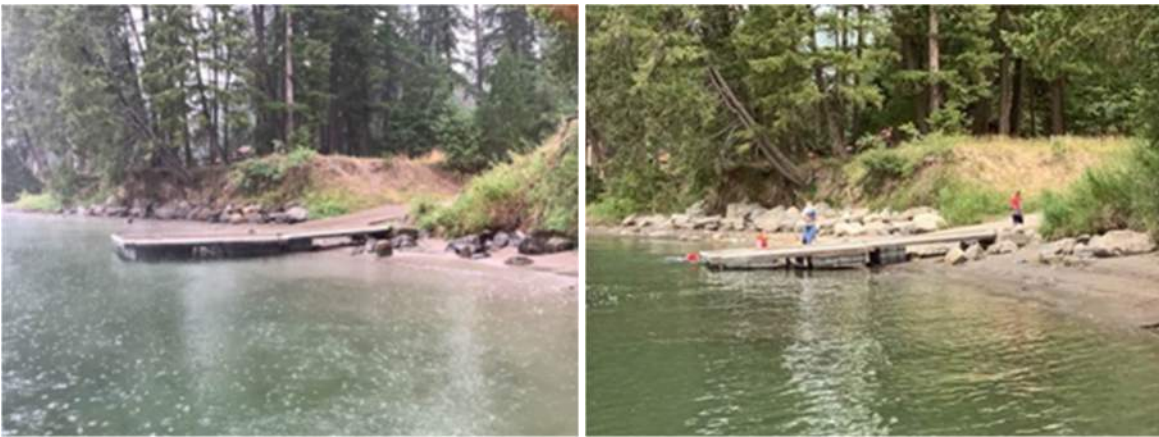
South shoreline area at Cherry Creek Boat Launch (public dock) at 1.0 foot below full pool (left, 2021 photo) and at 1.8 feet below full pool (right, 2022 photo).

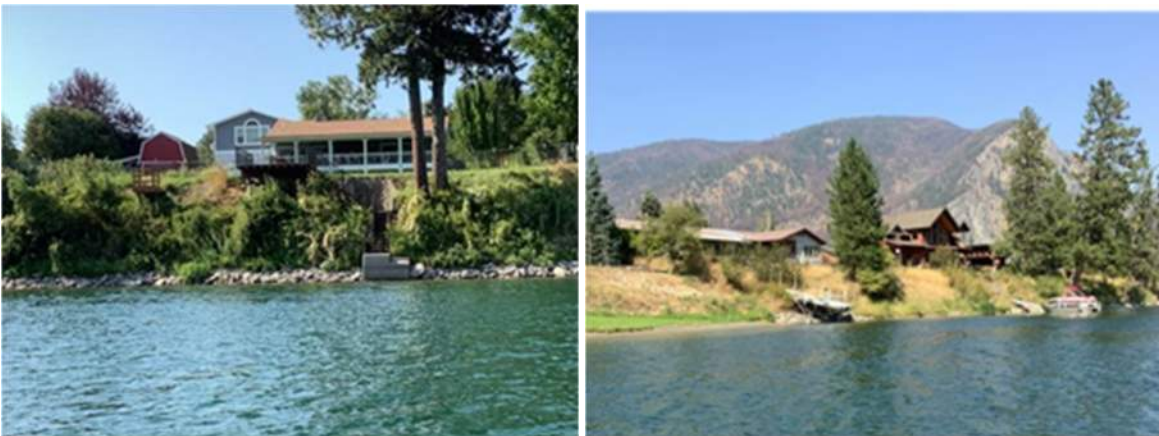
North shoreline areas upstream of Steamboat Island at 1.0 foot below full pool.

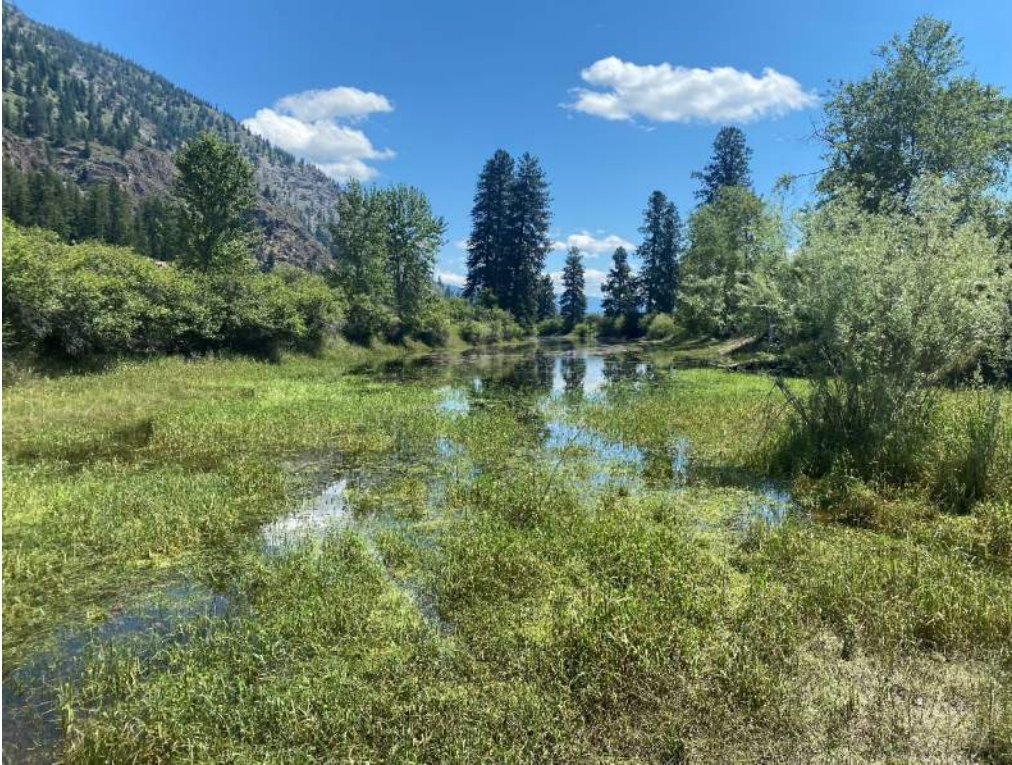
Photos 3-25. Wetland Control Site July 7, 2022

the water surface elevation of the Wetland Control site was slowly reduced through evaporation and discharge to surface water and groundwater until August 29, when the location where the stage logger was placed went dry. **Photo 3-25** shows a photo of the Wetland Control site on July 7 when the stage logger was installed, while **Photo 3-26** shows the Wetland Control site on October 25, which was the day that the logger was removed.
